By Kent A. Harries, Ph.D., FACI, P.E. Contributing Author

Patient J

Study takes close look at how J-bars hold up in Pa.

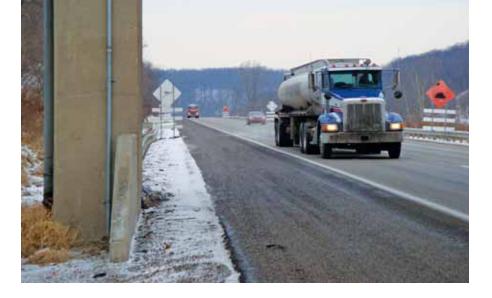
During the demolition process, little reinforcing bar corrosion was noted at any bridge. Concrete, both above and below the footing interface, was sound in all observed cases. Steel, when exposed during demolition, was uncorroded and "black." Most bars retained a thin layer of adhered cement paste, an indication of continued passivity of the bar.

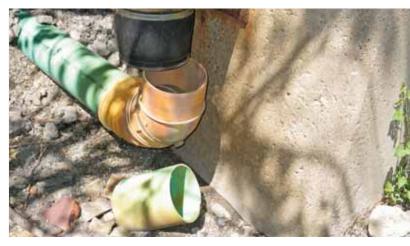
All samples were located at an interface of Class B (footing) and Class A (pier or stem wall) concrete. In all cases, this interface appeared to be well prepared, and when observable, sound bond between concrete lifts was evident. Samples included abutment walls having No. 4 or No. 5 J-bars and piers having No. 11 dowel bars. The samples included A615, Grades 40 and 60 bars, A408, Grades 40 and 50 bars, A431 Grade 75 bars and A432 Grade 60 bars. Beyond very minor surface corrosion, no evidence of corrosion at the pier-footing or stem wall-footing interfaces was observed in any sample.

For both new construction and structural rehabilitation, requiring epoxy-coated or other corrosion-resistant reinforcement across the footing interface, coupled with waterproofing the interface, represents the current best practice for mitigating potential deterioration of J-bars or dowel bars near pier/stem wall-footing interfaces.
