Difficult to face

Crews meet paving challenges on Homestake Dam

By Zachary Wirth, E.I.T.
Contributing Author

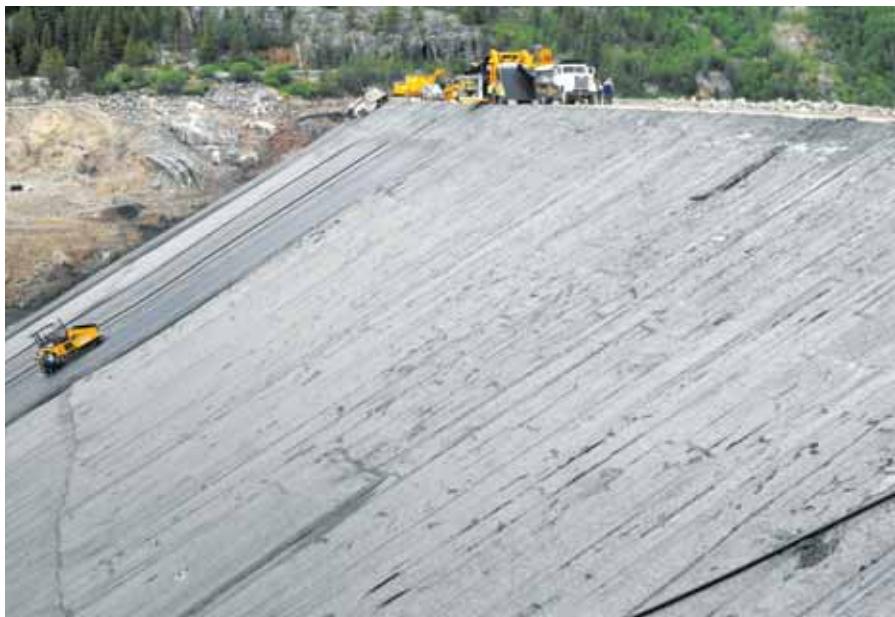
To properly place and compact the asphalt, large pieces of equipment, including a paver and rollers, were secured with cables attached to portable winches that allowed the equipment to be either lowered from the top of the dam or raised up the face.

The inherent steepness of the dam required working with extreme caution. Homestake Dam's crest is nearly 2,000 ft long. Because of that fact—coupled with the angle of the dam face—the job could be likened to paving a parking lot at a 35° angle. To properly place and compact the asphalt, a team with Colorado-based ACA Moltz JV arranged for large pieces of equipment, including a paver and rollers, to be secured with cables attached to portable winches that allow the equipment to be either lowered from the top of the dam or raised up the face. Workers seeking to take density measurements of the material have had to rappel down the face of the dam. In dealing with expensive equipment and valuable lives, the team had to be certain that nothing would slide freely down the face of the dam—and that every movement was calculated with the utmost certainty and precision.
