A triple lift

Amidst heavy and persistent traffic volume,
Prairie County, Ark.'s I-40 gets rejuvenated

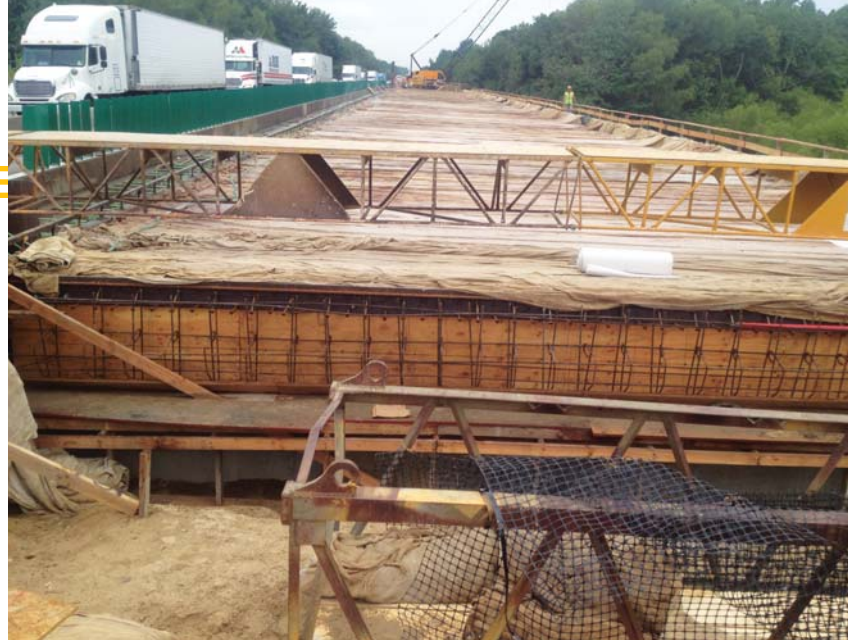
Both eastbound and westbound relief bridges to the White River were completely replaced from the footings on up.

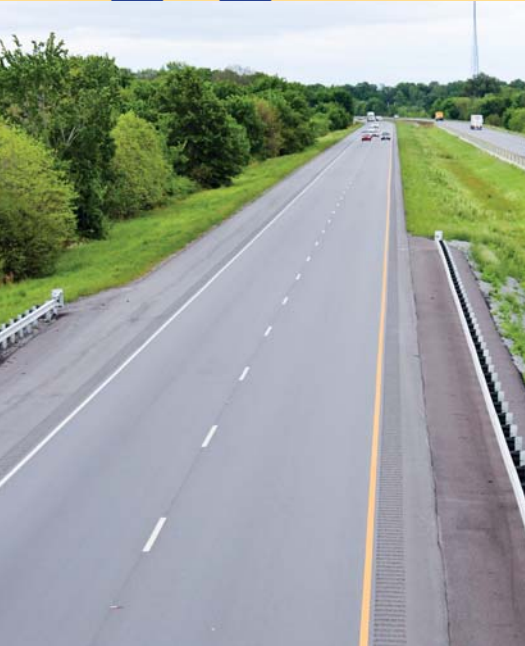
413,000 tons of asphalt were used to bring the 10.3-mile section of I-40 up a full foot.
