Mold crowning

Contractor finds key ingredient for barrier-wall job

JBI Construction faced a barrier challenge on I-65 in Louisville, Ky.

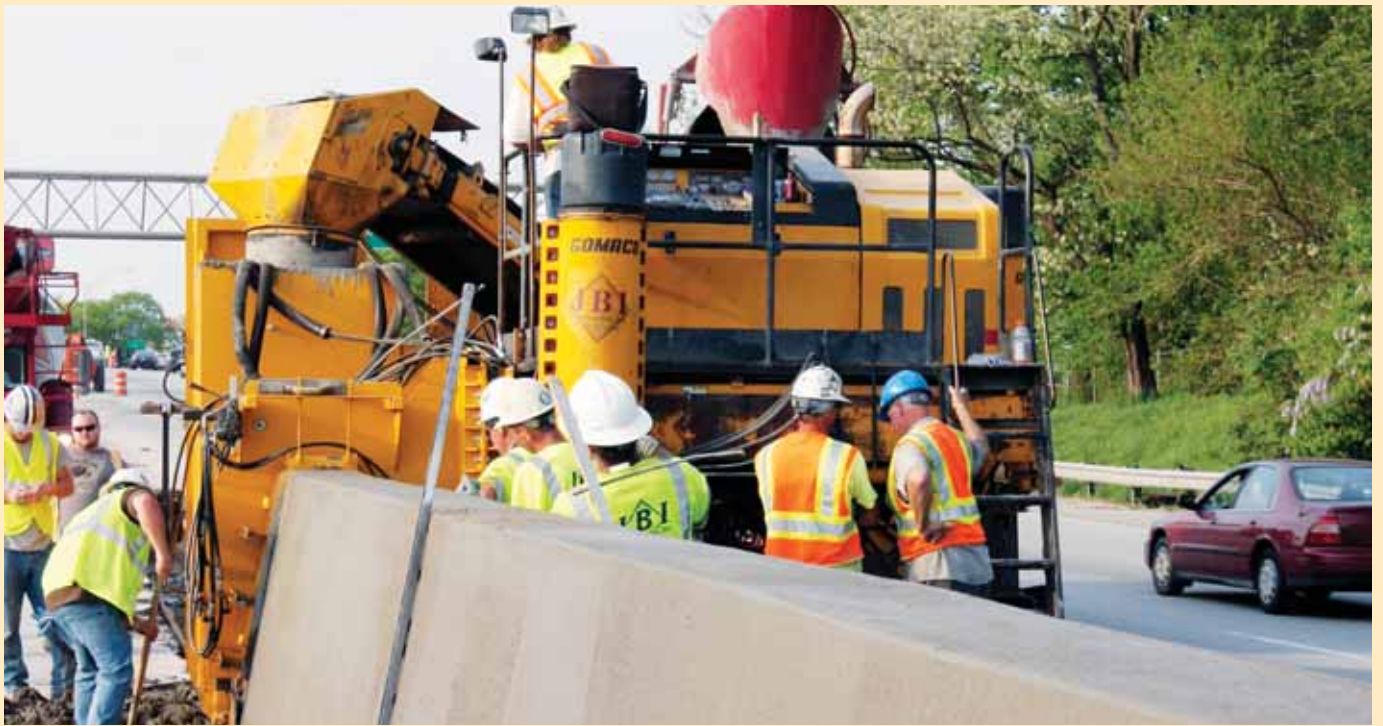
The barrier was slipformed over a trench that was left from the removal of the pre-existing 32-in.-tall wall.

The Commander III three-track was paving on the north end of the project and featured a new GOMACO-built barrier mold. The profile of the wall was 52 in. tall, with a 12-in. top width and 30 in. wide across the bottom. No steel reinforcing was used in the new concrete barrier.

The barrier was slipformed over a trench that was left from the removal of the pre-existing 32-in.-tall wall. The interstate remained open during the entire project.
