Good design hunting

Australian expressway poses geotechnical and environmental challenges

By Vince Urbano
Contributing Author

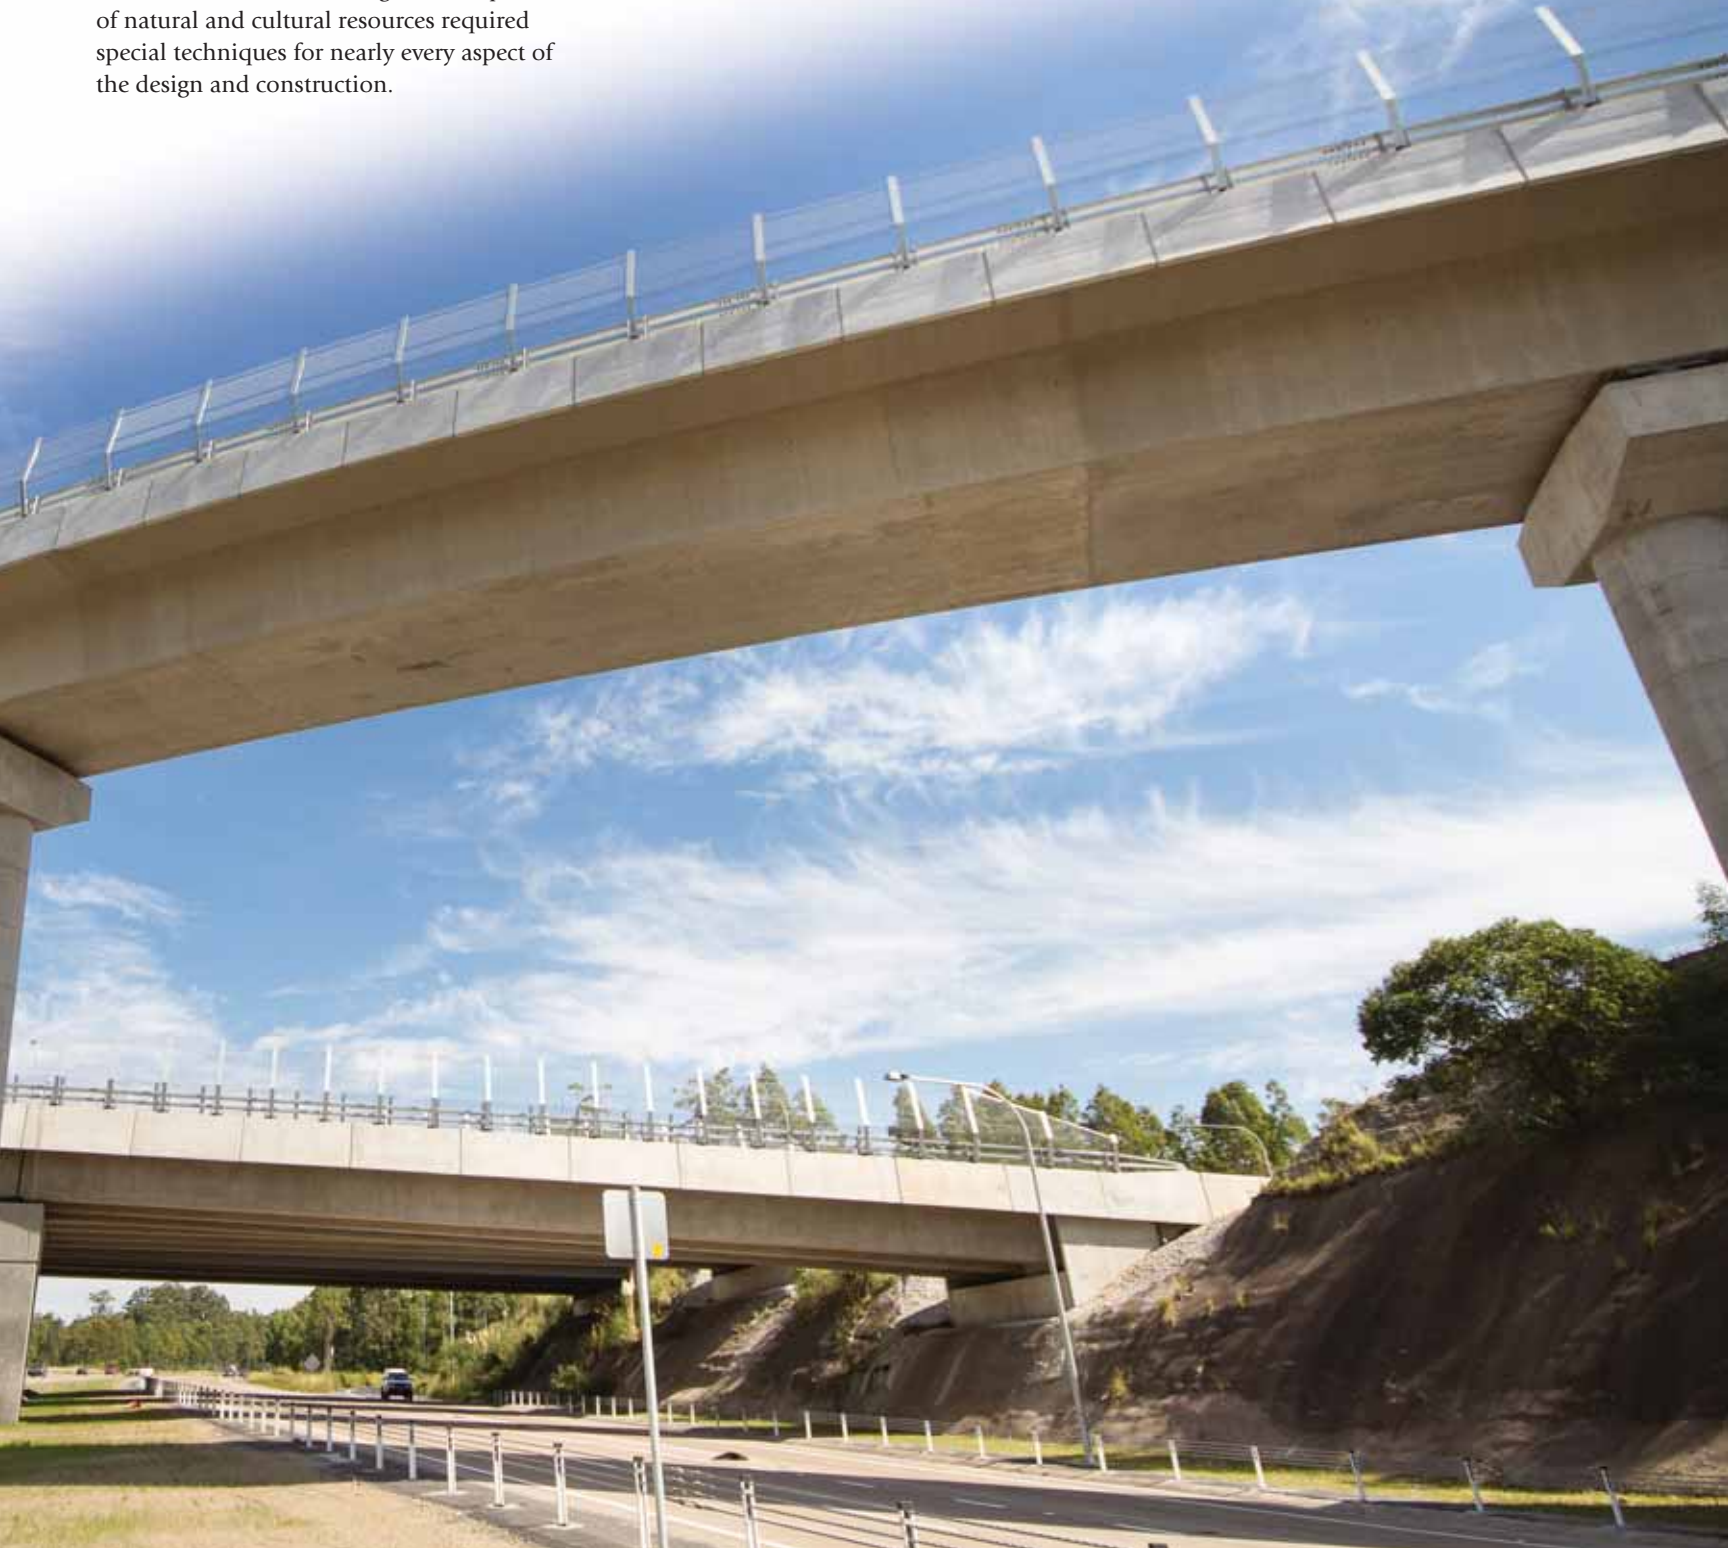
The alignment was shifted through the Sugarloaf Range and the highway elevated over deep gullies to tread more lightly on the landscape and enable wildlife to cross beneath.

gullies to tread more lightly on the landscape and enable wildlife to cross beneath. Changes were planned for area roadways to consolidate traffic onto the expressway, reducing net impacts. Strict clearing limits were imposed as part of the planning approval process. The total area cleared for construction on the alliance's section—including the highway elements, embankments, drainage basins and channels, precasting yard and construction access roads—has not exceeded 168 acres.

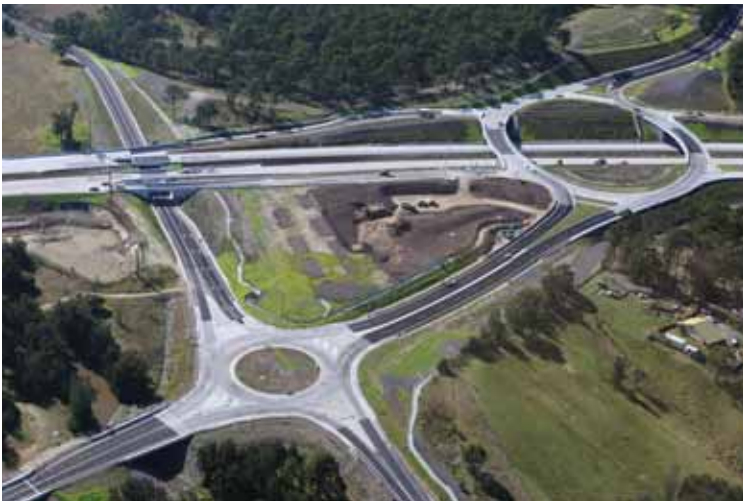
While mine stabilization addressed potential vertical movement of the ground, there was also a weak subsurface layer that could cause horizontal movement if mines beyond the construction footprint were to collapse.

While mine stabilization addressed potential vertical movement of the ground, there was also a weak subsurface layer in the corridor that could cause horizontal movement if mines beyond the construction footprint were to collapse. Considerable effort went into identifying

the zones vulnerable to movement. Where possible, viaduct piles were founded above the zone. Where piles had to be deeper, a double-cased eccentric piling design was used, with the center portion of the pile extending below the weak zone. Within the weak zone a ring of space between the pile and an outer sleeve allows horizontal movement up to 1 ft without damaging the viaduct formation.

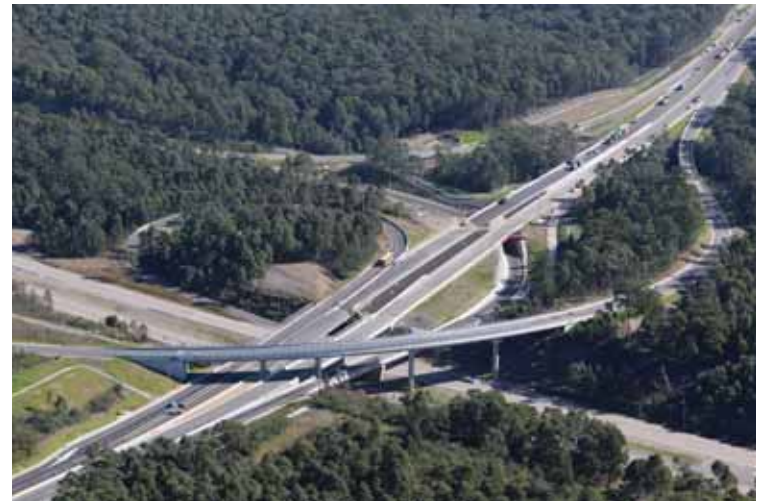
A video camera was lowered into each borehole to record the condition of the hole and the mine void. The observed conditions were compared to expected conditions, and adjustments to the treatment were developed as needed. More than 6,400 videos were assessed and more than 130 validation holes were drilled as part of the in-depth mine-void-fill validation process.

Mine areas were stabilized by drilling a series of boreholes into the voids and filling them with fly ash-cement grout. In all, more than 1,600 boreholes representing 155,000 drill meters were drilled and more than 7 million cu ft of ground was placed.

The boreholes were drilled from platforms to protect vegetation. Because the ground had to be stabilized well beyond the clearing boundary, a majority of the boreholes were drilled at an angle, increasing the length and complexity of the bore. Despite extensive geotechnical investigation, exact subsurface conditions at each location could only be determined after construction drilling. A video camera was lowered into each borehole to record the condition of the hole and the mine void. The observed conditions were compared to expected conditions, and adjustments to the treatment were developed as needed. More than 6,400 videos were assessed and more than 130 validation holes were drilled as part of the in-depth mine-void-fill validation process.
