Blue-tiful

Remote, mountainous location
recycles in place with great results

The Blue Ridge Parkway is a scenic highway set high in the mountains of Virginia and North Carolina.

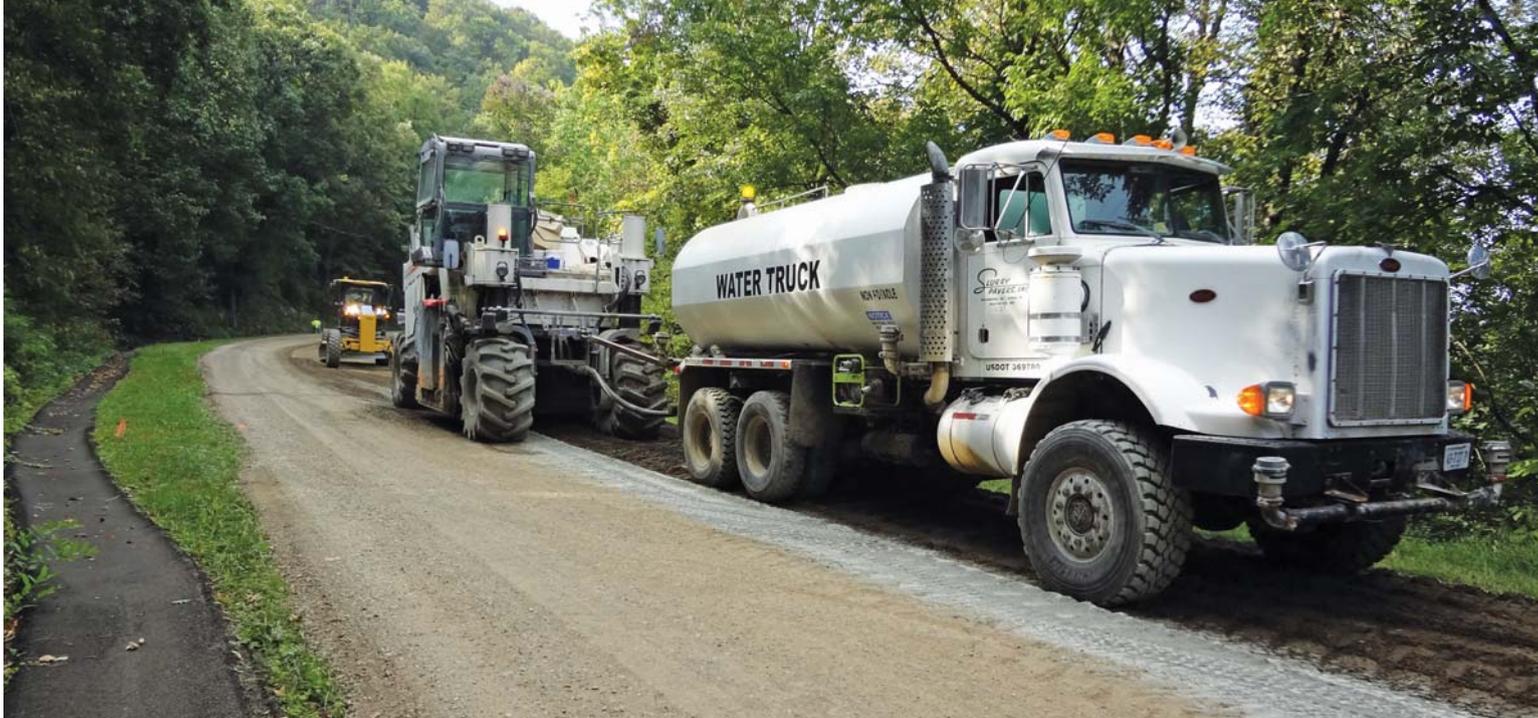
A 4,000-gal Kenworth water tanker makes its way down the Parkway trailed behind by a reclaimer.

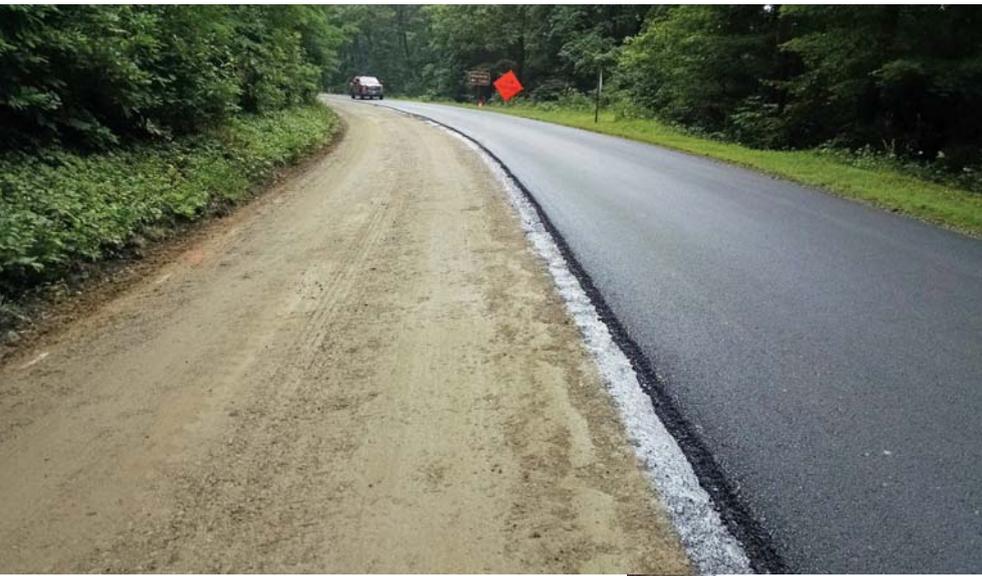
Left: Part of freshly surfaced ½ lane-mile.

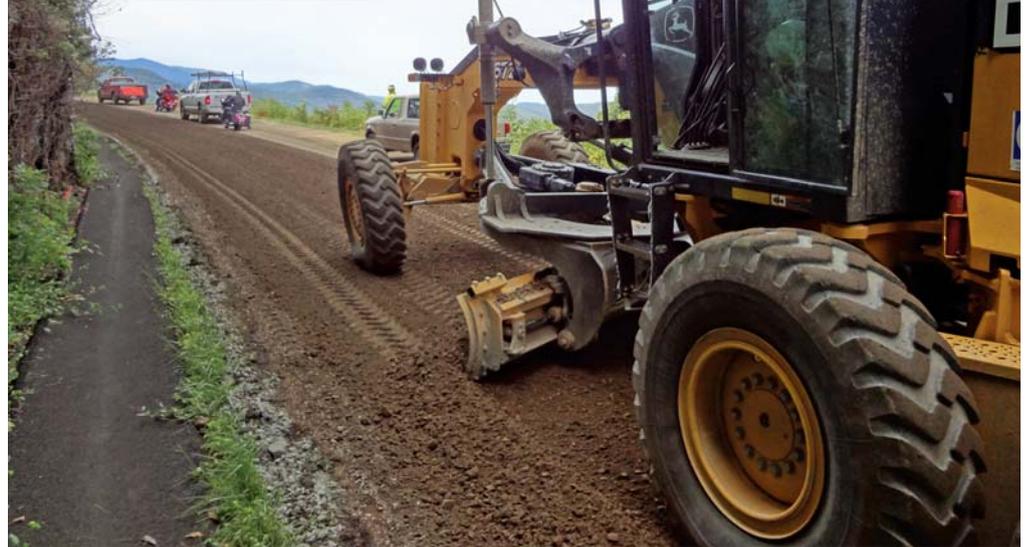
Below: A Deere 672G motor grader milled the base of the roadway.

The existing pavement was pulverized to the specified depth of 8 in. using a Wirtgen WR2500S reclaimer, typically for a distance of approximately 600-800 ft. Behind the reclaimer, a Deere 672G motor grader roughly shaped the pulverized base and made a small windrow on either side of the lane to hem in the raw cement during mixing. Once the pavement was pulverized and shaped, calibrated Kenworth cement spreaders went to work applying portland cement (with an allowable variance of 5% off testing rate). A Kenworth 4,000-gal water tanker was attached to the reclaimer and made a second pass to mix the pulverized pavement and cement, which was brought in from the mixing area at the foot of the mountain in a LBT Bulk Taker, or "Pig." During this second pass, the reclaimer injected water at a controlled rate during the mixing to bring the final mixture to within 2% of optimum.

Once more, the mixture was roughly shaped with the 672G motor grader and compacted in a 1-2-3 pattern that employed a Hamm 3412P combination roller until the mixed base "walked out." The Deere motor grader was then used to strike off the base and the surface was finished with a Hamm HD+120VP steel double-drum roller. Compaction testing was performed with a nuclear density gauge, and once compaction targets were verified, the reclaimed pavement was moist-cured overnight. Traffic was maintained on the completed FDR until the following morning, when the reclaimed road received its first layer of asphalt concrete surface.
