Quality roadwork

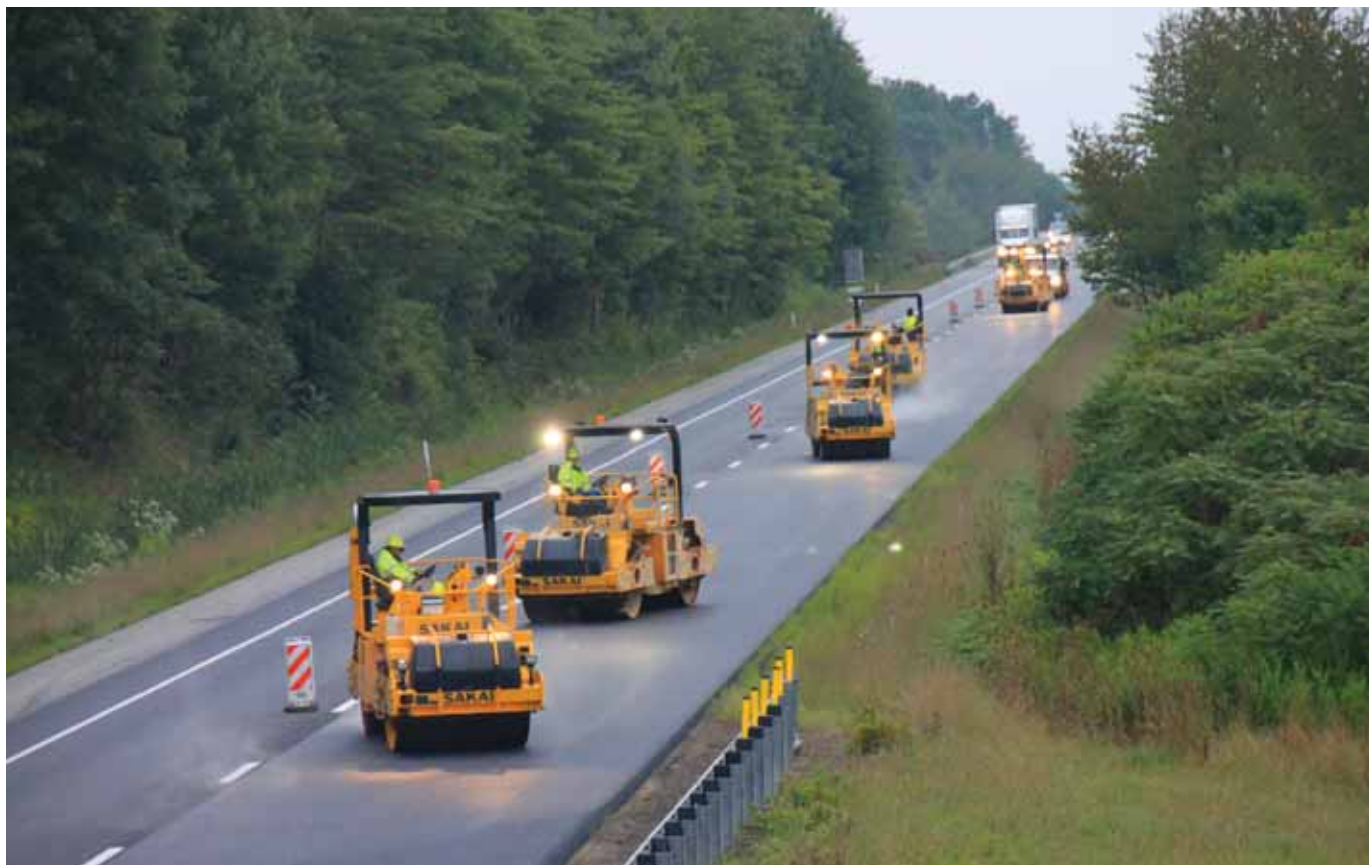
Four or five Sakai high-frequency rollers were used; the number of rollers was dependent upon the production schedule. The rolling pattern consisted of between five and seven vibratory passes per roller. The last roller in the paving train was operated primarily in the static mode. Whenever possible, all rollers would arc off the mat at the end of all passes onto a previously placed surface.

To make the road consistently smooth in ride and appearance, between four or five Sakai high-frequency rollers were used; the number of rollers was dependent upon the production schedule. A typical paving pass was either 15 or 16 ft wide on the SMA course. The rolling pattern consisted of between five and seven vibratory passes per roller. The last roller in the paving train was operated primarily in the static mode. Whenever possible, all rollers would arc off the mat at the end of all passes onto a previously placed surface.
