By Tiphaine A. Ketch, P.E., CFM, and Jeffrey Smith Contributing Authors

No issues with weight

Historic bridge in New York state revitalized

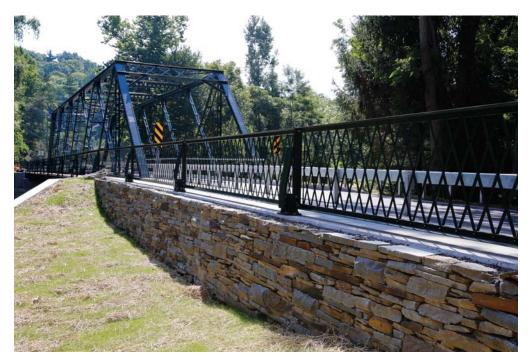
Above: The Ithica, N.Y., bridge is registered in the National Register of Historic Places; its original truss steel dates from the Model T era and had a 15-ton load restriction.

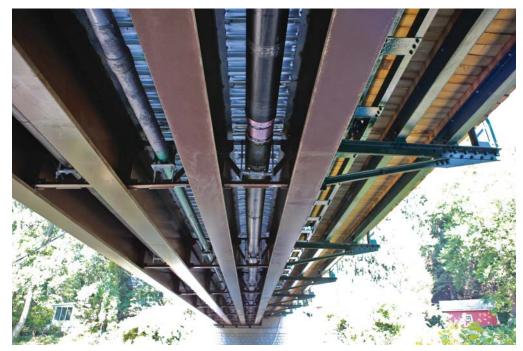
Below: The steel multigirder superstructure allowed the removal of weight restrictions while preserving the historic flavor of the original truss structure. Moreover, three bays carry water, sewer and gas lines between Cornell University and the Forest Home community.

steel multigirder superstructure with a composite concrete deck. The new superstructure spans the creek independent of the trusses, which remain in place, preserving the bridge's historic appearance and allowing the removal of weight restrictions.

As a solution, variable-depth girders were designed to minimize impacts to both the roadway profile and the hydraulic opening. The roadway's vertical profile is built into the girders, which are 31 in. deep at the abutments and 42 in. deep at mid-span. The top flanges of the girders follow the vertical curvature of the roadway, and the bottom flanges are straight, an innovative design for a multigirder bridge. While the use of non-prismatic girders is not unprecedented, it is unusual to have the

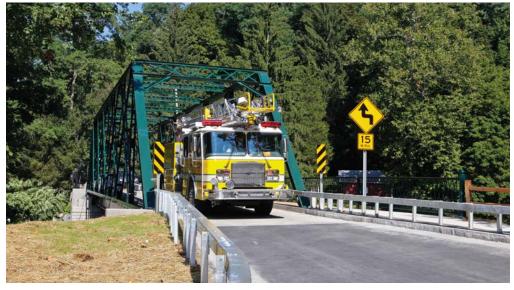
The Cayuga Heights Fire Department celebrated the completion of the new bridge by sending its heaviest fire truck across Fall Creek when the bridge opened to traffic.

George Tamborelle, chief of the Cayuga Heights Fire Department, expressed a great deal of enthusiasm for the new bridge, saying, "We are thrilled that the new bridge has no weight or height restrictions. We hadn't driven over the bridge since 2003. No more circuitous detour routes." In fact, the chief sent his heaviest fire truck to be one of the first to cross the bridge when it opened to traffic. **R&B**
