# A feeding frenzy

WSDOT works under fire to get I-5 bridge up again

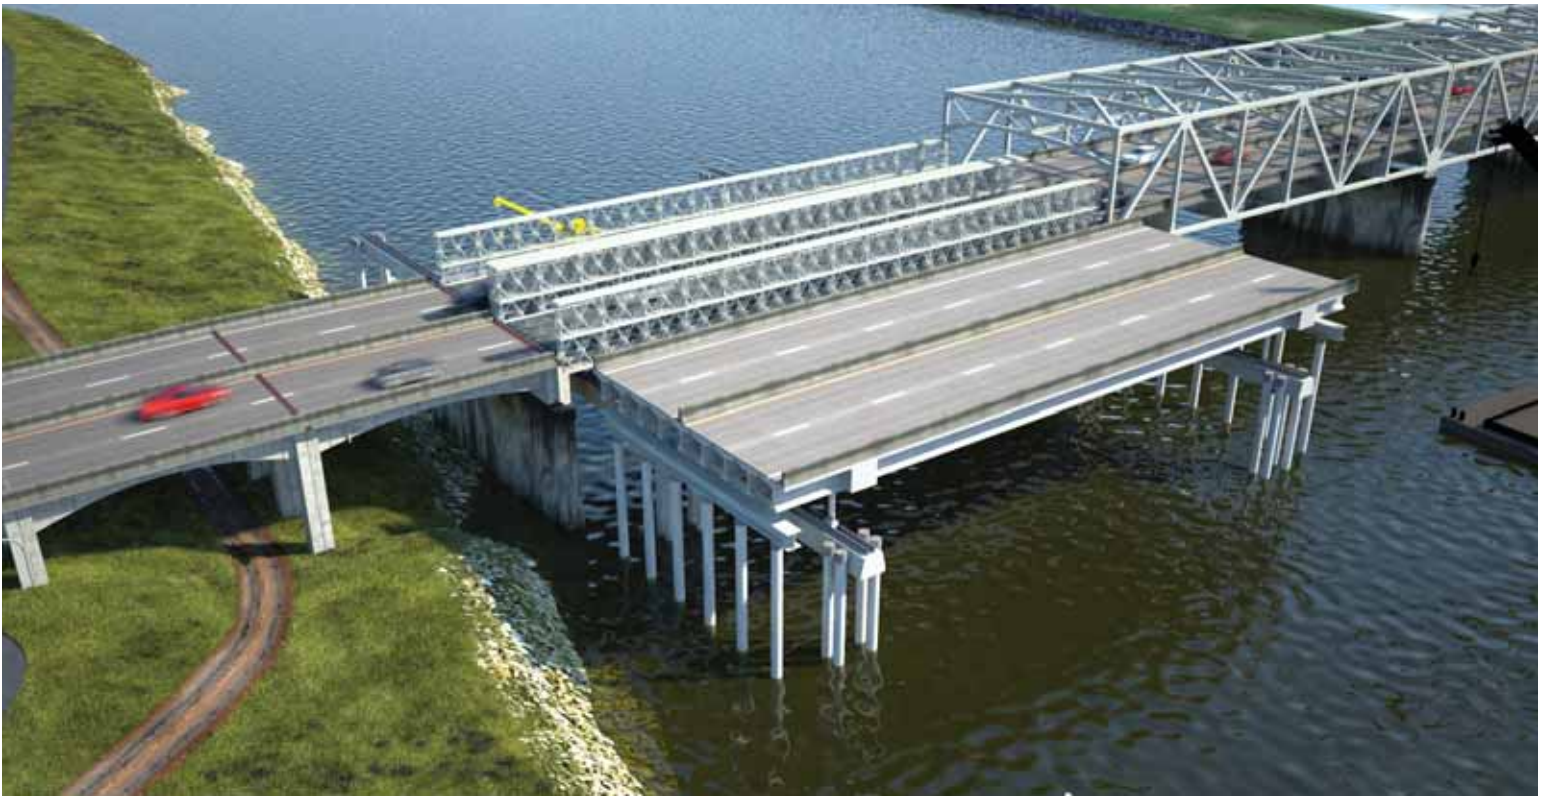
The winning bidder decided to go with a bulb-T lightweight concrete girder design for the permanent span.

During the first week of June WSDOT began working on the design-build contract to permanently replace the lost section. Because they were still dealing with the existing piers, the repair had to be of a certain weight, and contractors could go with bulb-T prestressed, precast concrete girders or steel girders. The winning bidder, Max J Kuney Construction, Spokane, Wash., and Parsons Brinckerhoff (\$6.88 million), decided to go with a bulb-T lightweight concrete girder design, and on July 12 work began on driving steel piles just downstream of the existing I-5 bridge. A total of 12 24-in.-diam. piles were installed to hold the new permanent structure, and 56 24-in.-diam. piles were placed for the skidding bents, which would help slide the permanent deck onto its final

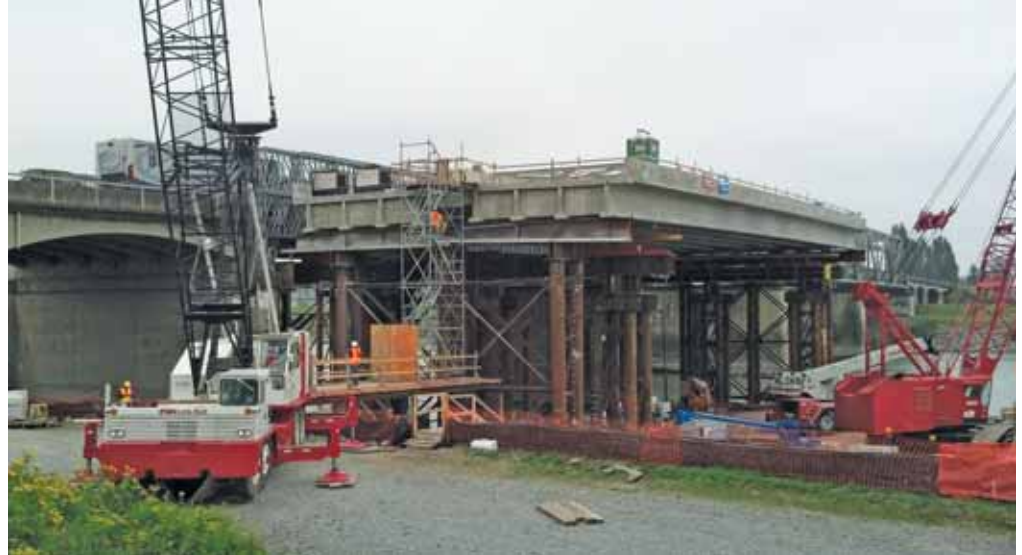
The girders have very wide top flanges, so the distance between each girder was 12 in. except in the center where crews were going to cast a median barrier, which required a 4-ft-wide closure pour.

The girders have very wide top flanges, so the distance between each girder was 12 in. except in the center where crews were going to cast a median barrier, which required a 4-ft-wide closure pour. Two end diaphragms and two jacking diaphragms, inserted in alignment with the temporary bents and slide rails, were installed next. All four were cast in place, as were the concrete barrier walls, one in the center and two located on each edge of the deck. A 1.5-in. micro silica deck overlay was then poured. Crews also had to construct pedestals on the existing piers to allow the new section of the bridge to line up with existing spans on each side.
