Losing a companion

New deck in place to help prevent moisture damage

Moisture is a constant companion, and threat, to the Hamilton Fish Newburgh-Beacon Bridge.

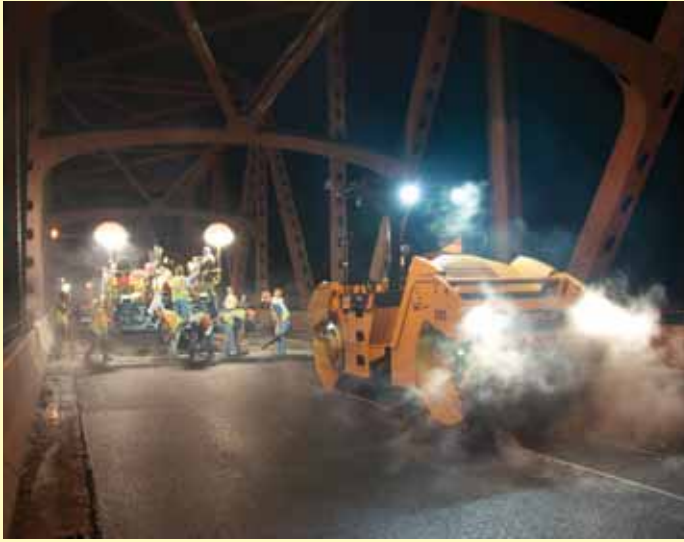
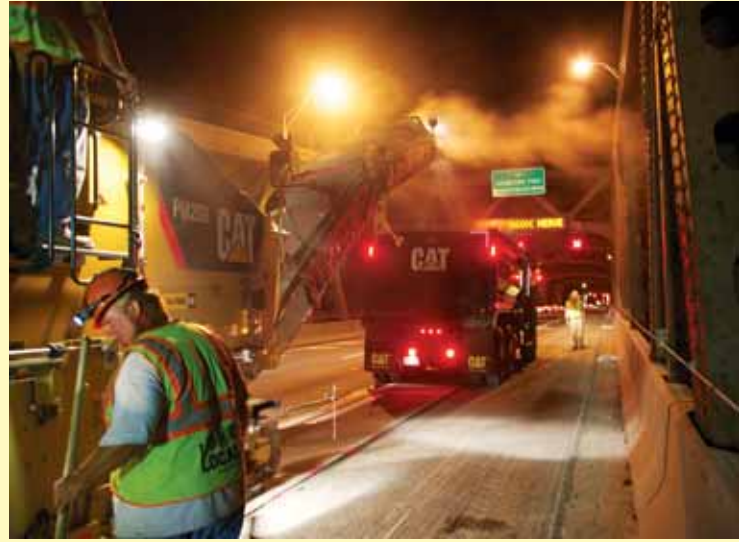
All work on the 1,000-ft twin-span three-lane bridge took place at night. Crews were allowed to close one lane at 7 p.m. and the second lane at 9 p.m. That left one lane open at all times. Sections of the road were milled and paved in a single night. Crews had to be off the road by 6 a.m. Bridge authorities were determined to make the resurfacing last.
