Able to reconnect

Warm mix plays big role in Colo. flood recovery

By Tom Kuennen
Contributing Author

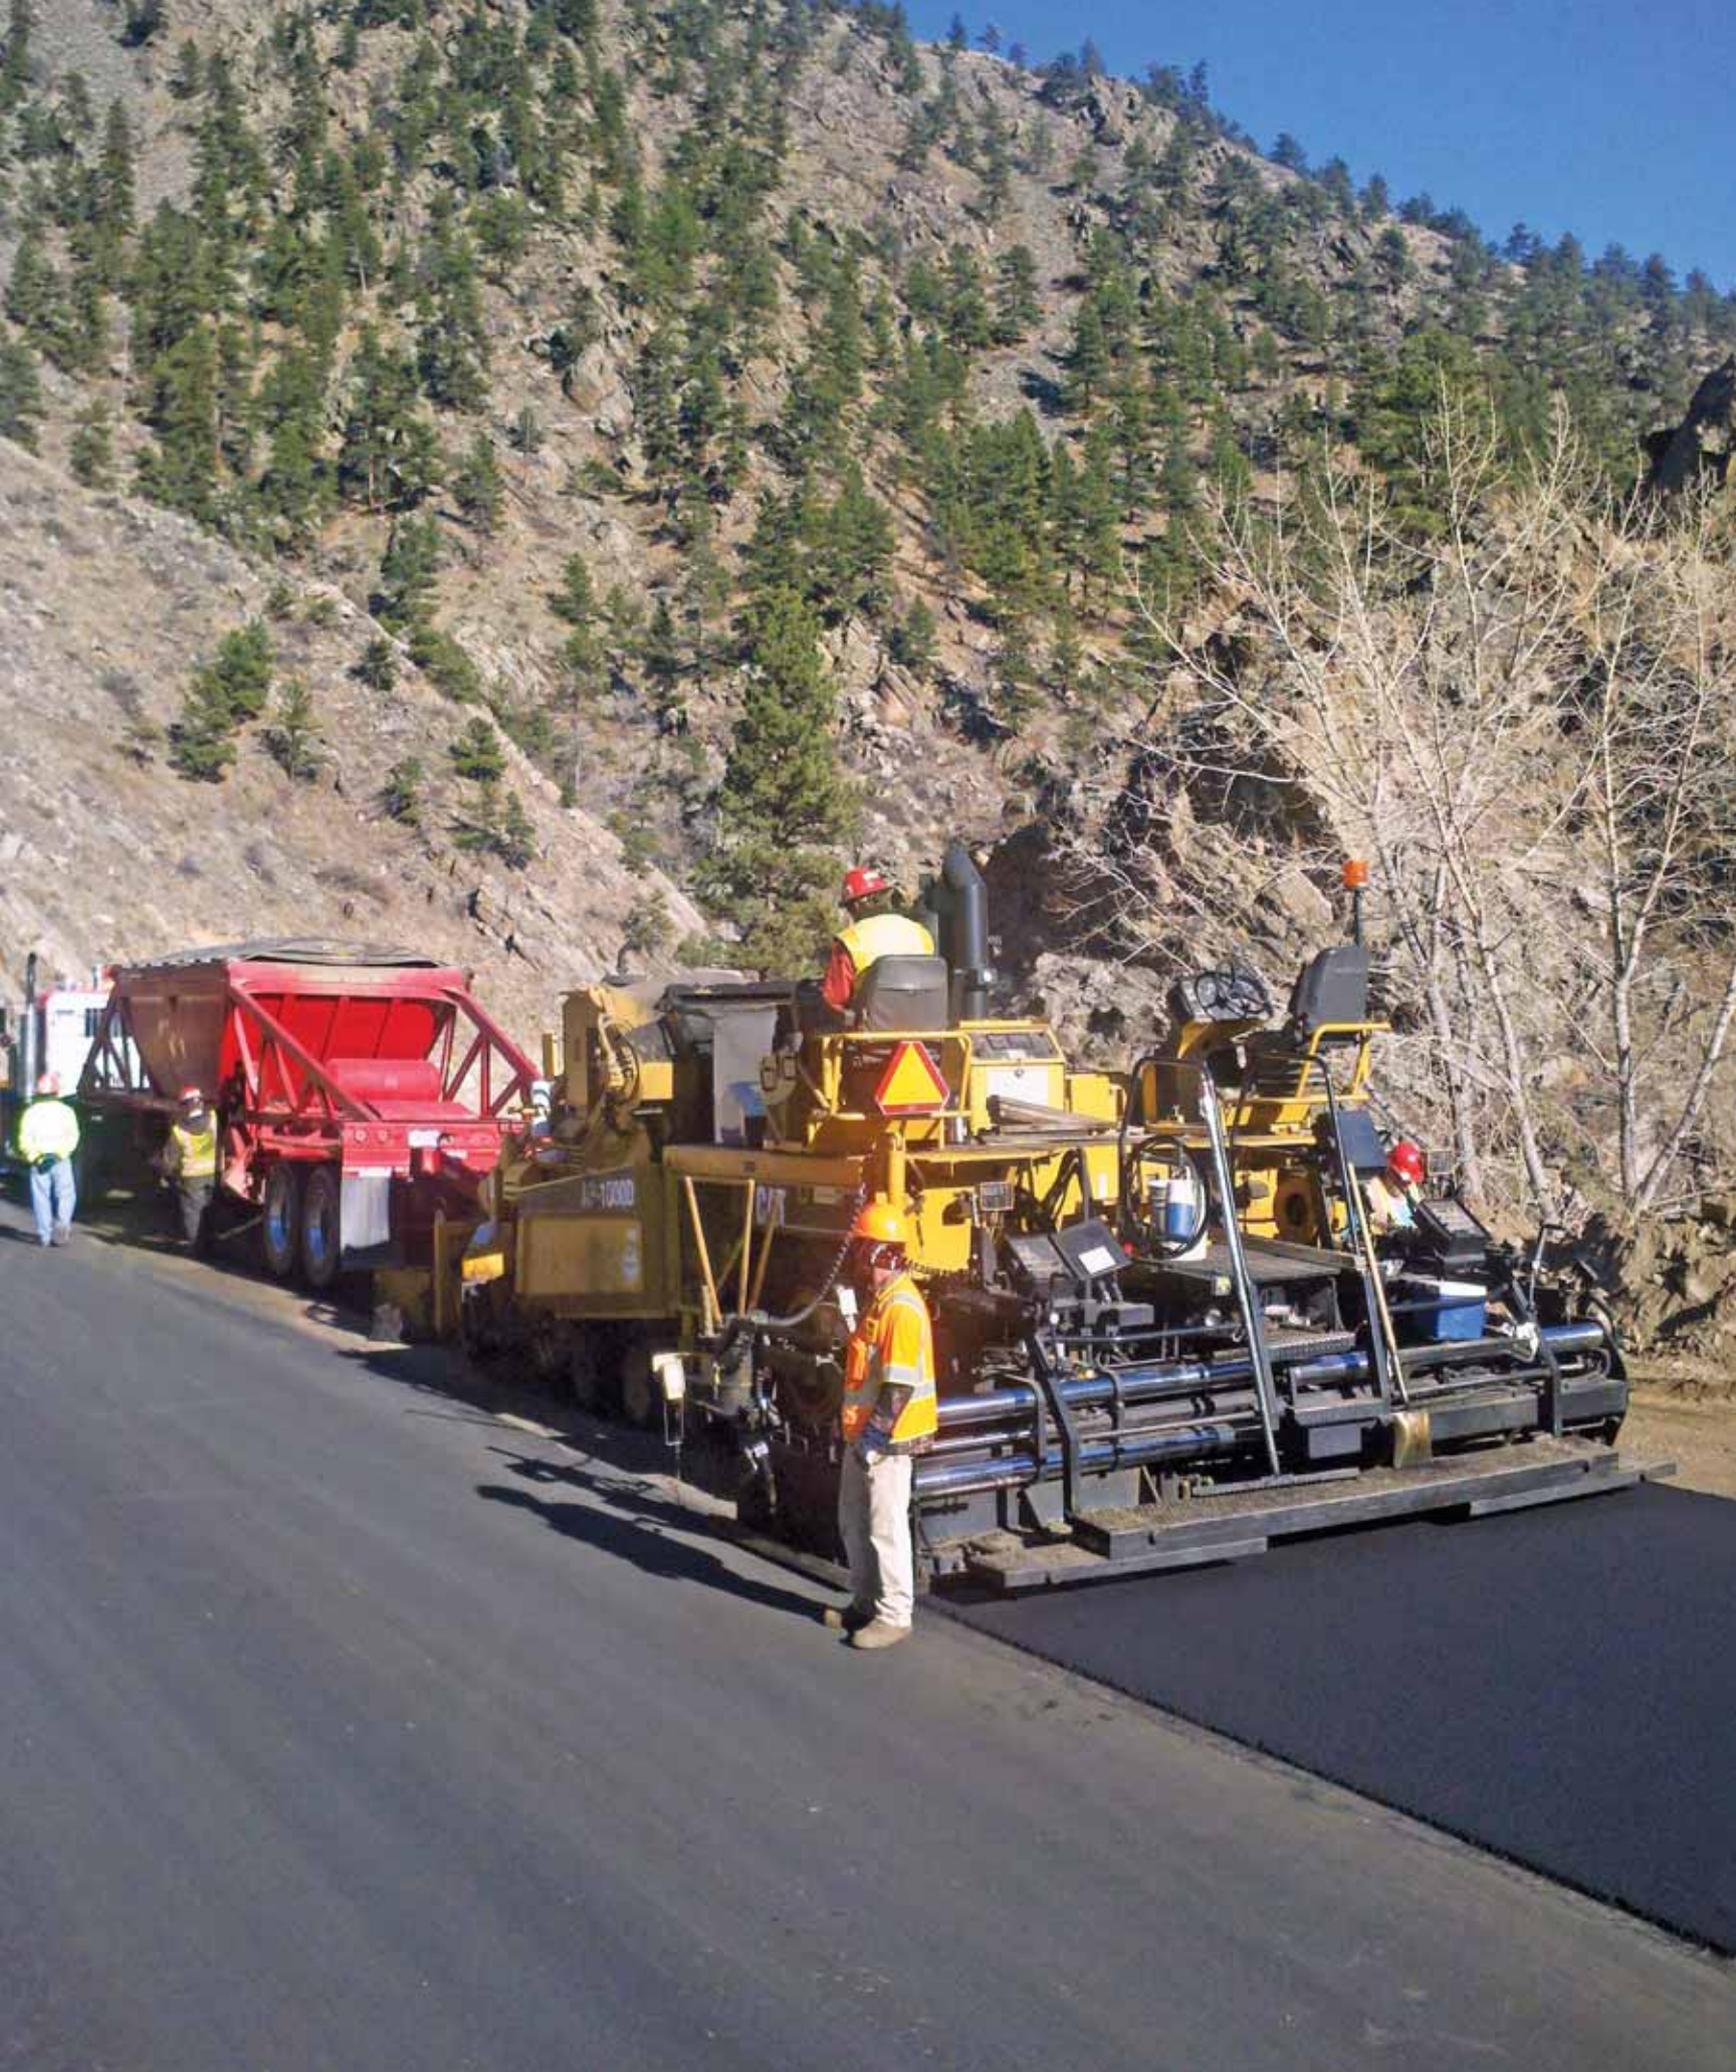
The effort to provide temporary road repairs to reopen access to homes and towns before winter was daunting. The last major highway was reopened in November. Photo courtesy of MWV Evotherm.

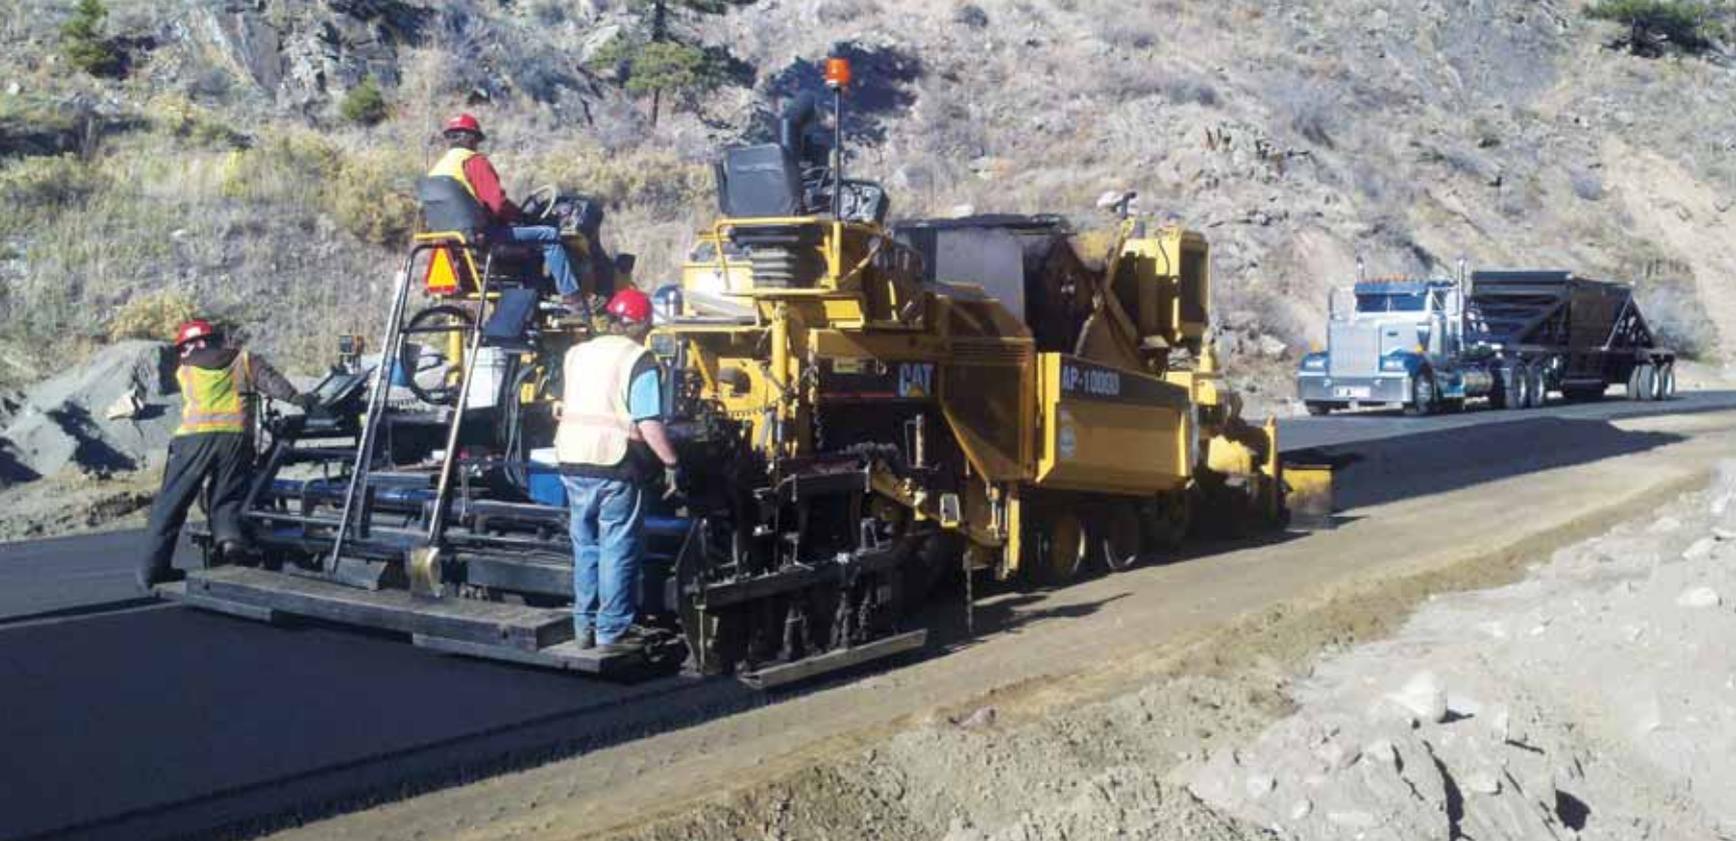
To maintain asphalt workability, forces of Coulson Excavating pave U.S. 34 between Loveland and Estes Park with warm-mix asphalt due to long hauls of up to three hours, low ambient temperatures at the end of the season and high elevations. Photo courtesy of MWV Evotherm.

In some instances, long haul distances during which mixes would cool, low ambient temperatures due to high elevations, and work late in the paving season dictated use of warm-mix asphalt (WMA) to ensure workability. For example, WMA was used extensively

on reconstruction of U.S. 34 through Big Thompson Canyon.

"Warm mix has proved to be an aid in marginal-weather paving," Peterson said. "And up in those canyons, with the winds and high elevation in November, the marginal weather there is ideally suited for warm mix. It gives the contractor mixes that will stay workable while meeting the spec requirements. Evotherm warm-mix technology provided the quality and ability to place the material successfully in marginally cold weather."
