A start for stops?

São Paulo on crusade to improve pavement at bus stops

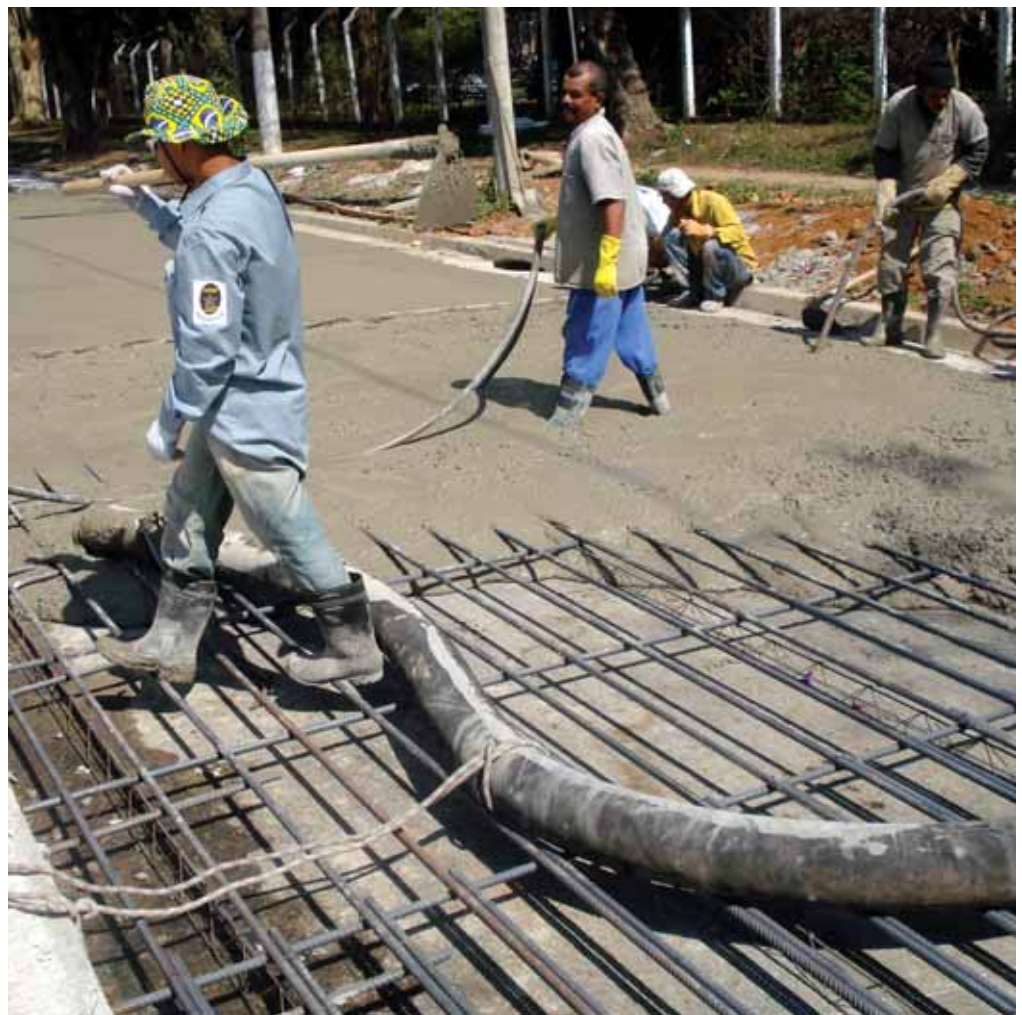
The first continuously reinforced concrete pavement in Brazil was built at the University of São Paulo during the winter of 2010. It was originally intended to verify, for tropical conditions, the occurrence of transverse cracks and its comparison to crack patterns in other climates.

The first continuously reinforced concrete pavement (CRCP) in Brazil was built at the University of São Paulo during the winter of 2010 (July to September). It was originally intended to verify, for tropical conditions, the occurrence of transverse cracks and its comparison to other crack patterns in other climates. The idea of a seamless concrete pavement was enticing, since most of the concrete pavement distresses verified over the decades in Brazil were related to contraction joints and dowels and tie bars, especially on bus corridors in large cities of the country. Poor construction control of such critical elements in PJCP leads to several possible distresses like faulting, pumping, spalling, corner breaks, etc., and led officials to believe CRCP could take the place of PJCP in bus-stop areas treated as a reinforced pavement with longitudinal and transverse bars without requiring saw-cut or transverse joint dowels for one-lane traffic. Therefore, four short lanes (50 m each) of CRCP were built. The use of short slabs, lacking anchors at section ends, allowed researchers to check the opening of shrinkage cracks within the system. The traditional CRCP behavior in the matter of dry shrinkage is well known and understood. Short CRCP slab cracking should be evaluated because crack spacing is crucial in establishing design parameters.

The entire four-lane, 200-m length is composed of 240 mm of portland cement concrete (MR > 4.5 MPa), a hot-mix asphalt (HMA) base of 60 mm and 200 mm of dry macadam as a sub-base over a clay subgrade. HMA was used as a base course to aid diminishing thermal gradients in concrete slabs, since in tropical conditions the thermal differentials between slab top and bottom reaches 26°C during the summer. The four

sections have different percentages of steel (0.4, 0.5, 0.6 and 0.7%). The experimental lanes of CRCP were built manually using lateral wood forms. Each lane section was 50 m long and 5.05 m wide. All of the building steps were carried out manually, from the placing of steel bars to the surface finishing (texturized with brooms).

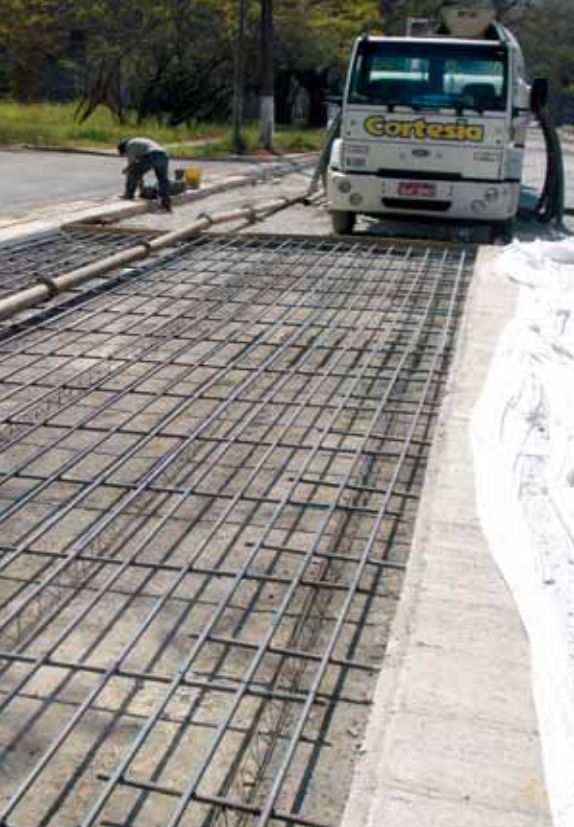
The short CRCP sections built at the University of São Paulo developed a few transverse cracks since construction in 2010. After one year, the cracks were quite different from conventional CRCP.

During the first year weekly surveying showed cracks did not arise in the slab concrete surfaces (at least to the naked eye). However, this situation changed drastically after October 2011, when the first crack was observed, in Section 3, located on the opposite side of the transverse joint between

As of March 2013, the average spacing between the cracks in the short CRCP slabs is twice the value observed on U.S. highways over the last five decades—4.55 m and 6.25 m in sections 3 and 4, respectively. The average crack width in May 2013 was 0.17 mm in Section 2 and 0.55 and 0.33 in sections 3 and 4, respectively, at 16°C. During the summer

The short CRCP sections built on the University of São Paulo campus developed a few transverse cracks since construction in 2010. After one year, the cracking patterns on the short sections of CRCP were quite different from conventional CRCP. The effect of minimal anchorage in the CRCP slabs resulted in a delay of shrinkage cracks on the concrete surface, an unexpected result for CRCP supported by research. Large spacing between the shrinkage cracks has been observed. Deflections also have shown to be a relevant effect of steel percentage in stiffening the short CRCP sections, resulting in a better
