By Michael Irwin, P.E., and Todd Stephens, EIT Contributing Authors

Hurricane Bridge receives much-needed rehabiliation

mithville, Tenn.'s Hurricane Bridge carries S.R. 56 over Center Hill Lake, a route that serves as a major connector for all of mid-Tennessee.

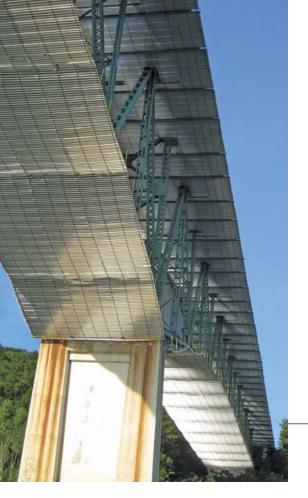
Modjeski and Masters designed an unusual gusset-plate retrofit that could be performed in the field without stopping traffic on the bridge. The vertical member loads at these gusseted connections were temporarily transferred to adjacent panel points through the use of a topside spreader beam.

vertical member loads at these gusseted connections were temporarily transferred to adjacent panel points through the use of a topside spreader beam. The beam, located on the top of the deck, spanned multiple panel locations and was fastened to adjacent floorbeams with vertical rods. Next, the bottom portion of the truss vertical was cut and removed to provide access to the joint. New gusset-reinforcing plates were then added to the inside of the existing gussets and connected to the new spliced bottom portion of the vertical member using long-shaft bolts. Adhering to this procedure and retrofitting only one joint at a time ensured that the stability of the truss would not be compromised during the repair.

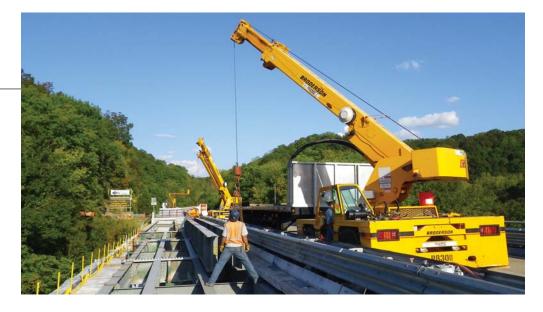
Modjeski and Masters also had to be mindful of environmental concerns, making sure the rehabilitation did not negatively impact the pristine lake crossed by this bridge, a hub of trout and bass fishing. Because of the age of the bridge and the severity of its deterioration, crews needed to be especially cautious that no debris fell into the riverbed below. Like many of its era, the original structure contained lead-based paint, which needed to be both removed and safely contained in order to protect workers and the nearby community during repainting. The contractor, OCCI Inc., used both conventional tarps and innovative Safespan under-bridge decking to prevent the release of lead into the atmosphere, the waterway and soil. The under-bridge decking

system also helped to ensure worker safety and mobility during the construction process.

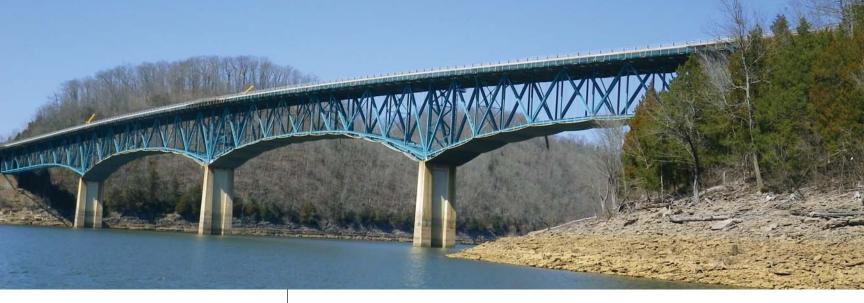
The continuous-truss construction necessitated very specific construction staging load patterns and intensities in order to prevent unacceptable stress reversal and to limit the magnitude of temporary stresses and loads on truss members and gusset plates. salts. This innovative design application should help increase the service life of the new deck and minimize future maintenance of the superstructure.
