# SAFETY 2013: RURAL ROAD CURVES

Improving retroreflectivity on curves has modest effect

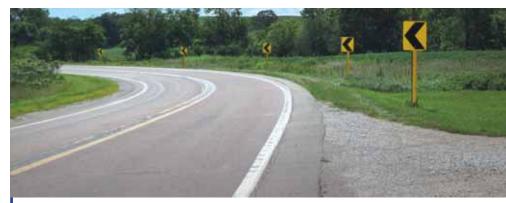
Reflective post treatments were added to the posts of existing chevrons at four curves. The post treatment adds delineation to reinforce the presence of a curve to drivers.

Reflective post treatments were added to the posts of existing chevrons at four curves. The post treatment adds delineation to reinforce the presence of a curve to drivers and can be effective for several reasons. First, it draws attention to the curve so that drivers who did not receive other cues are able to detect the curve. Second, it can help drivers

Retroreflective strips were added to the front and back of existing wood chevron posts facing both directions on U.S. 52, 221st Street and Iowa S.R. 141. A 60-in. polypropylene tube coated with yellow high-intensity sheeting was wrapped around existing Telspar chevron posts at Y-52.
