Can't stress enough

Scanning wood guardrail posts is a necessity

By Evan Olszko and Don Bender
Contributing Authors

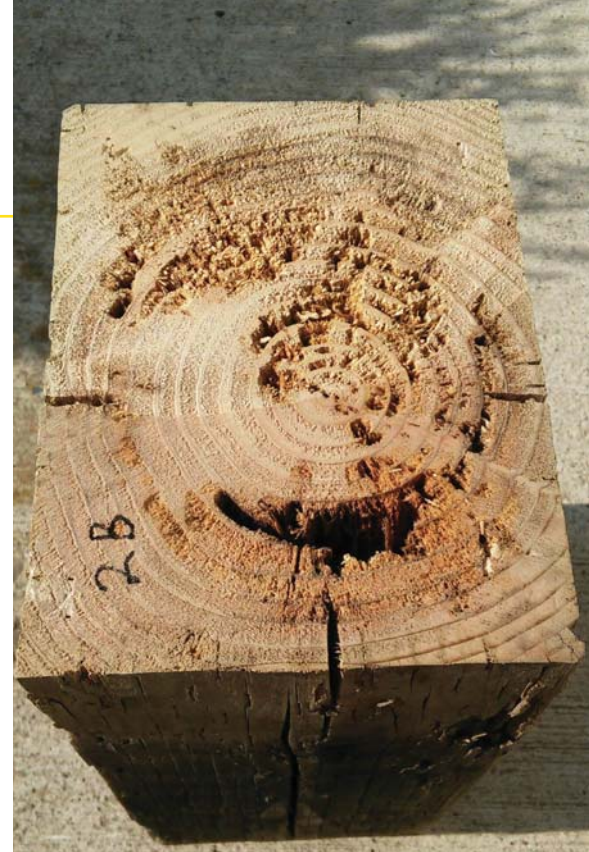
A prototype field device to identify internal post conditions.

An example of the decayed interior of a guardrail post.

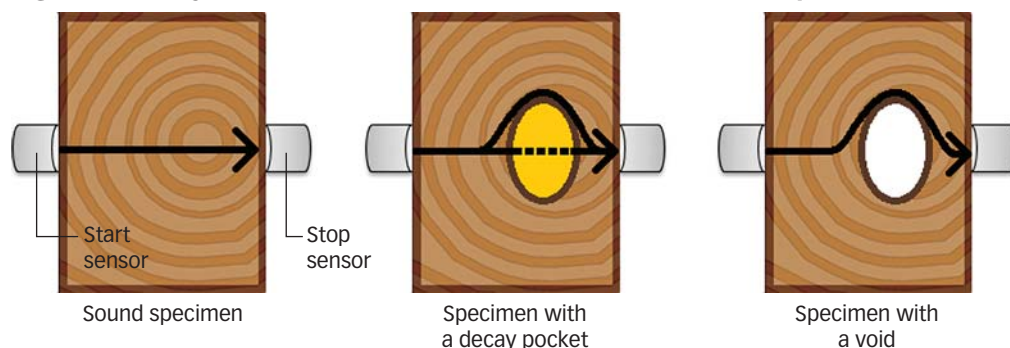
Figure 1. Decayed wood or voids alter the stress-wave travel path.

The SWT method is illustrated in Figure 1, showing how decayed wood or voids alter the stress-wave travel path. Note the dashed line on the decayed specimen, indicating a slower wave velocity through the decay pocket. If the decay is severe enough or if a void forms, the stress wave must travel around the defect to reach the stop sensor.

Sounding involves impacting the post with a sounding hammer and listening to the resulting sound. This method is popular due to simplicity and low cost, but it is not very reliable and can be affected by factors such as moisture content and surface conditions. Stress wave timing (SWT) is a more sophisticated way to measure stress-wave transit time and calculate resulting wave velocities through a material. Sound wood results in faster velocities, while decayed wood results in slower velocities.

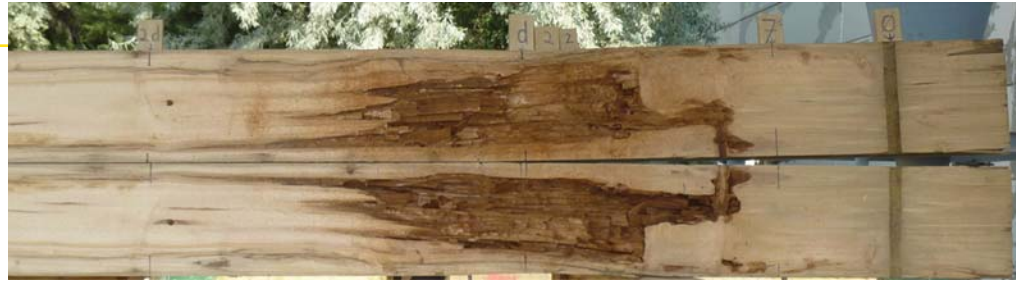
Figure 2. Wave speed vs. position on a laterally separated, decayed post.

To test the new SWT prototype, 193 wood guardrail posts were obtained from the Washington State Department of Transportation, tested non-destructively with the prototype and then tested with a destructive bending test. After destructive testing, the guardrail posts were ripped, length-wise, in order to determine true internal decay levels. Figure 2 shows an overlay of a decayed post

that was ripped and opened for viewing, with the corresponding stress wave velocities. The stress waves were obviously slowed by the internal decay.
