Waterproofing the Montsouris Reservoir: Using Hydraulic Binders and Nonwoven Geotextiles to End Leaks

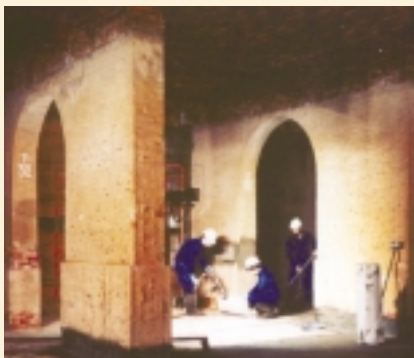
▲ After scouring the support to uncover a sound structural surface, a primer is applied that mineralizes the capillaries and microfissures, thus regaining cohesion in depth.

In practice, the treatment consists of applying, after scouring the support to uncover a sound and solid structural surface, a primer based on the principle of silicic mineralization of concrete. "This strengthens and reinforces the substrate by means of crystallizing elements that mineralize the capillaries and microfissures, thus regaining cohesion in depth," said Jean Pierre Bron, general manager of Kristo.

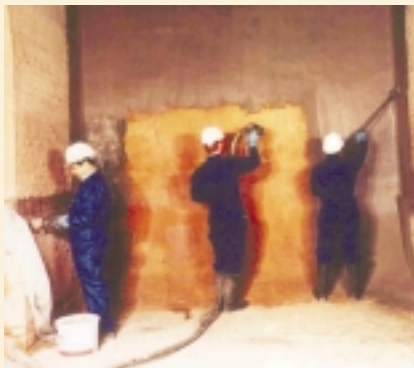
▼ Three layers of waterproofing product are sprayed on, the second layer being reinforced with a nonwoven geotextile.

Three layers of waterproofing product then are sprayed on. These consist of an impermeable compound based on hydraulic binders and resins in dispersion, the second layer being reinforced with a non-woven geotextile.
