# BRIDGE CONSTRUCTION

## Sound Investment

*One-of-a-kind bridge's reconstruction includes numerous challenges*

The 42nd Street Bridge over Amtrak and Norfolk Southern is a three-span, through-deck, concrete-filled steel arch bridge. Built just after the turn of the century, this one-of-a-kind bridge spanned over a very busy Pennsylvania Railroad rail bed and led into an affluent section of West Philadelphia—the home of the 1876 Centennial Exposition.

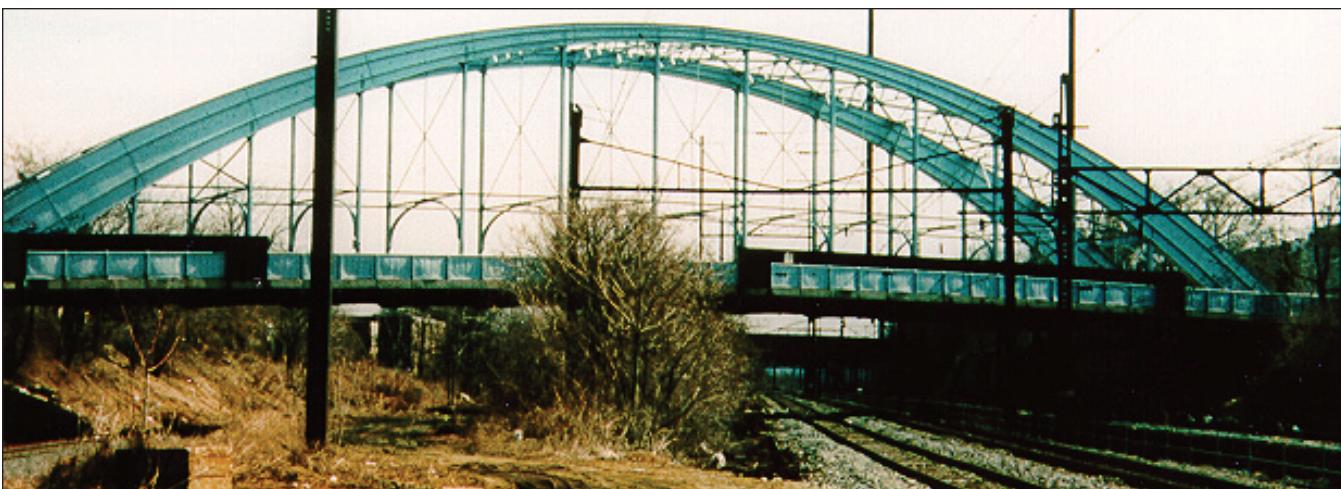
**The design approach taken would be to remove and replace the entire superstructure, except for the arch boxes. All of the substructures would be removed and replaced, except for the thrust block foundations.**

The design approach taken would be to remove and replace the entire superstructure, except for the arch boxes. Likewise, all of the substructures would be removed and replaced as well, except for the thrust block foundations. All of the work was

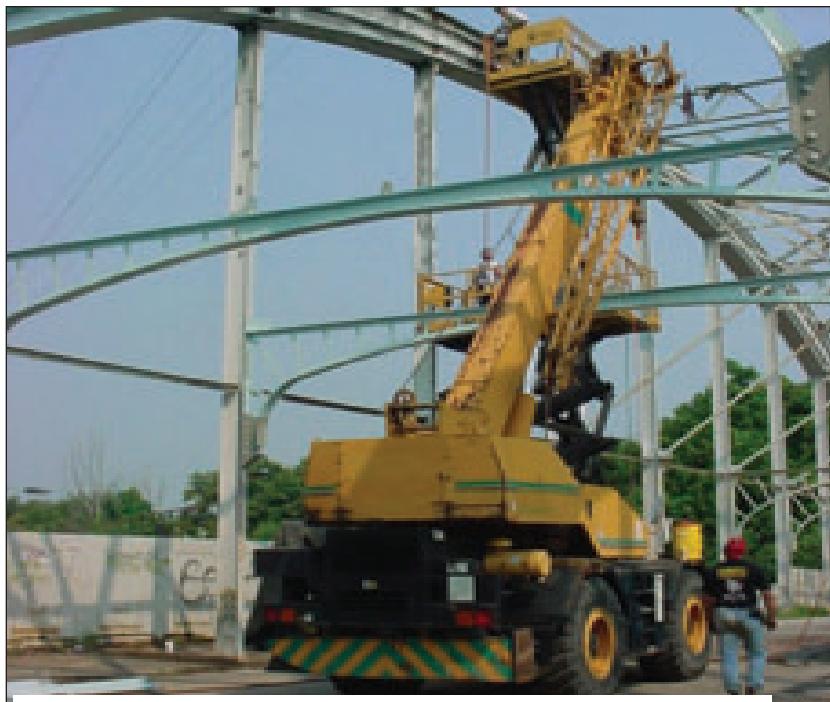
The rehabilitation of the 42nd Street Bridge was a sound investment. First and foremost, it restored a historic landmark.

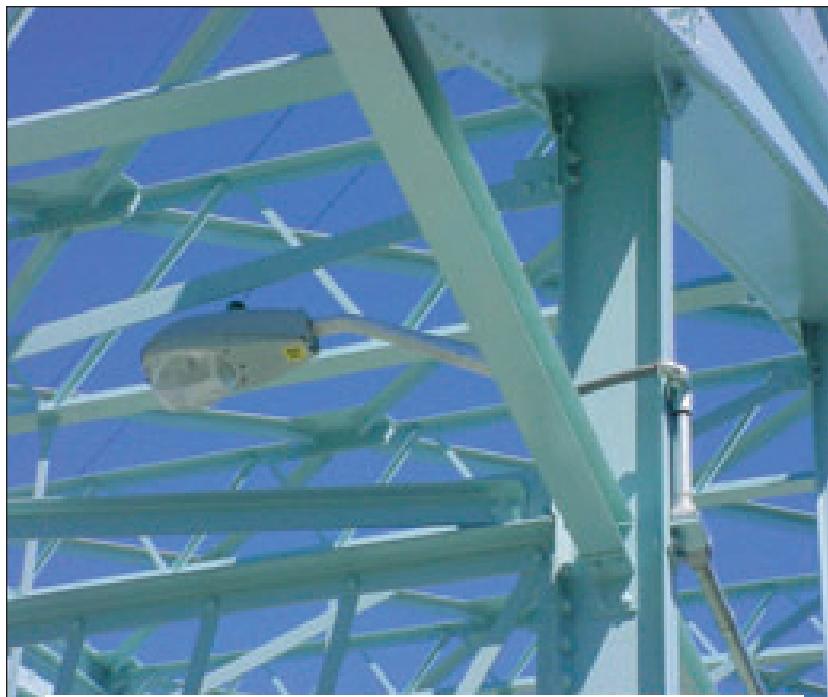
**Lights were evenly spaced across the main span and were mounted higher and directly to the hangers.**

With such a large span, lighting was an issue at night. The existing bridge had only two lights toward the center of the structure. The existing lights were low and were not hidden well within the aerial bracing. Four new lights would be evenly spaced across the main span. These lights would be mounted much higher and directly to the hangers. Also, the conduit runs from the lights would be hidden at the columns and behind the aerial struts to promote aesthetic appeal.
