A vortex of progress

Crews meet the challenges behind replacing structurally deficient Lafayette Bridge

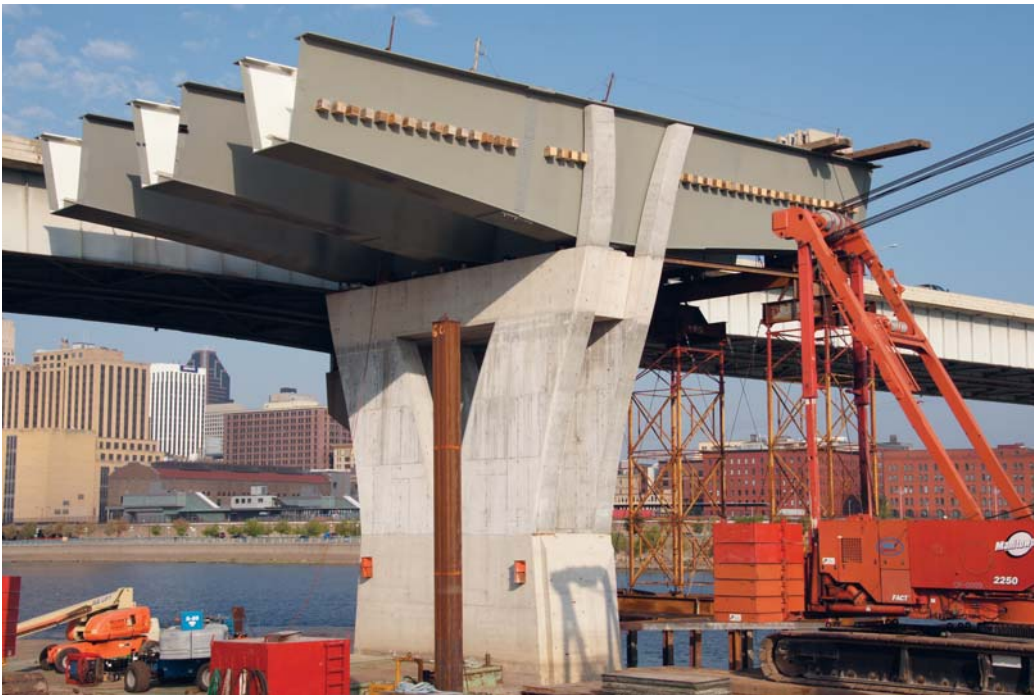
Cranes set the three lines of tub girders on the north end first, and half of the total number of girders for the northbound bridge were in place during the winter of 2012-13. Lunda Construction used shoring towers for erection up to the river.
