Getting clearance

CFRP U-wrapping shows promise as a repair option

By Adel ElSafty, P.E., P.Eng.
Contributing Author

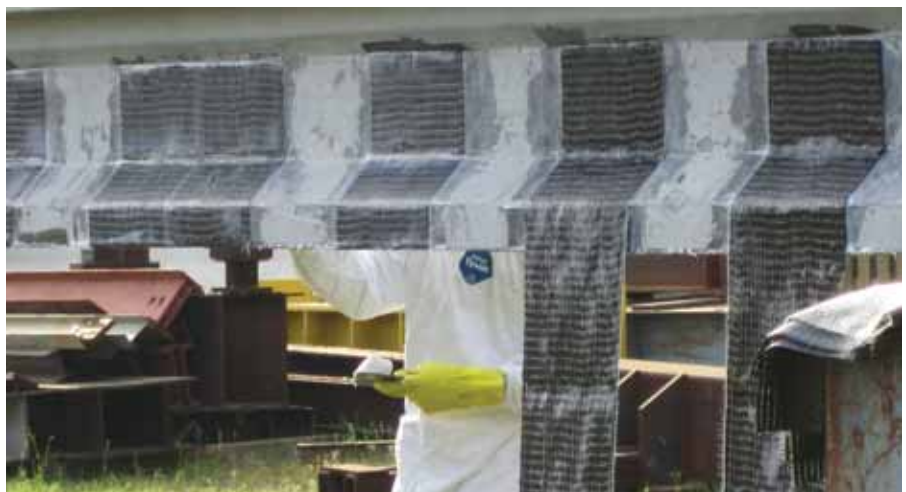
The half-scale and full-scale girders had a variety of repair configurations with several numbers of CFRP layers and with different spacing for the U-wraps. The full-scale PSC girders statically tested were arranged in a similar manner to the half-scale specimens.

The half-scale and full-scale girders had a variety of repair configurations with several numbers of CFRP layers and with different spacing for the U-wraps. The full-scale PSC girders statically tested were arranged in a similar manner to the half-scale specimens. The 40-ft-long PSC girders spanned 38 ft and rested on neoprene pads. The girder loading was applied using a steel spreader beam resting on another set of two pads. Also, load measurements were read by the data acquisition connected to the actuator. The deflection gauges positioned at mid-span were linear variable differential transformer (LVDT) deflection and laser gauges. The LVDT deflection gauges also were placed both above the supported

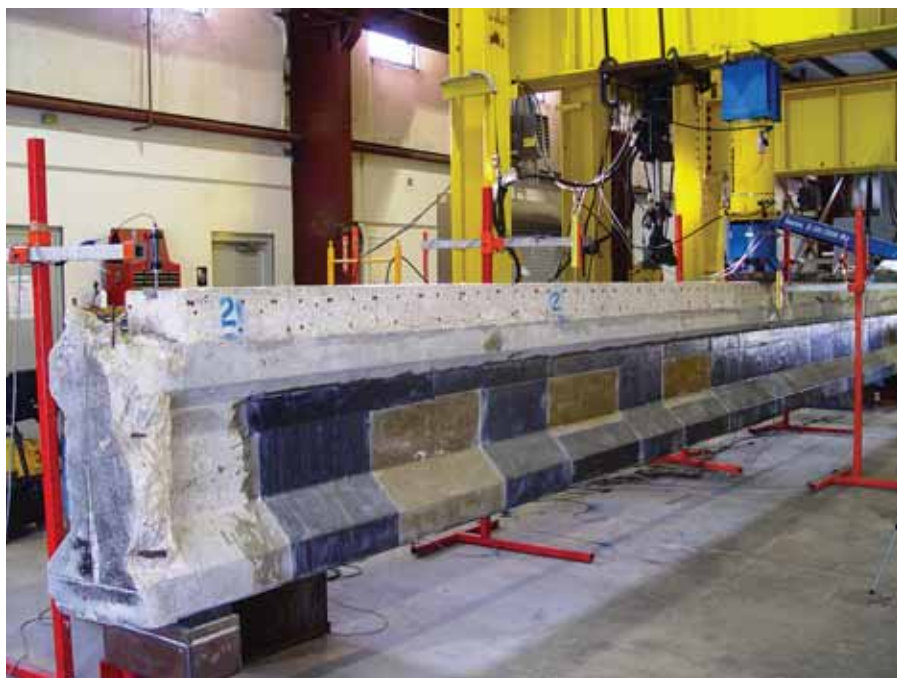
The girders were tested using the hydraulic actuator mounted to a steel frame at mid-span. The fatigue testing of AASHTO II girders was performed using the 110-kip MTS hydraulic actuator selected based on its large-capacity servo valve.

The girders were tested using the hydraulic actuator mounted to a steel frame at mid-span. The fatigue testing of AASHTO II girders was performed using the 110-kip MTS hydraulic actuator selected based on its large-capacity servo valve, which permitted testing of the girder using a frequency of 2 to 4 Hz. The loading contact area was a 250-mm by 500-mm steel plate specified by AASHTO. Neoprene pads were used at girder supports to simulate field-supporting conditions.

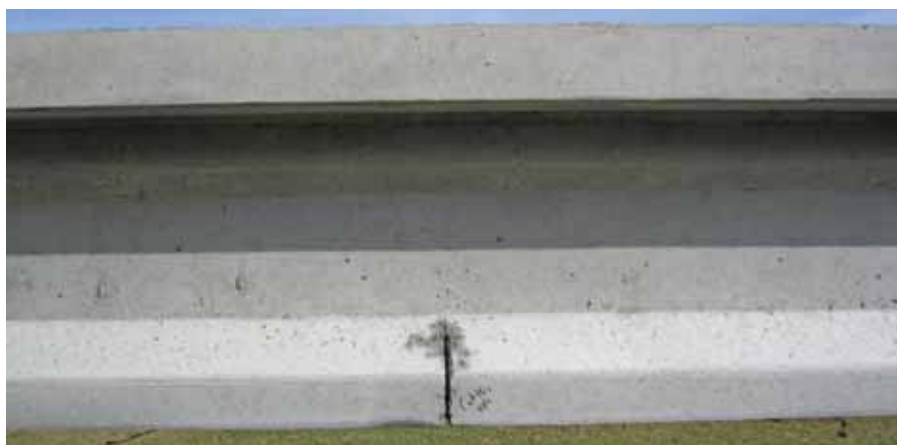
The lateral damage simulation for each girder was achieved by sawing through the concrete of the bottom flange and slicing through one of the prestressing strands.

The lateral damage simulation for each girder was achieved by sawing through the concrete of the bottom flange and slicing through one of the prestressing strands. To repair the cut, the surfaces exposed by cutting were first roughened with chisels to improve

bonding quality. These surfaces were then thoroughly cleaned with a water jet and pressurized air, as specified in both NCHRP 514 (NCHRP R-514) and ACI 440.2R-08. The cleaned cut was filled with a high-strength cementitious repair mortar, and a high-pressure epoxy injection procedure was performed after the mortar set. The procedure resulted in a near-perfect repair of the concrete cross section.
