Pouring over details

Asphalt pavement stands up to northern Minnesota's extreme weather and attracts Hayes attention

By Allen Zeyher
Managing Editor

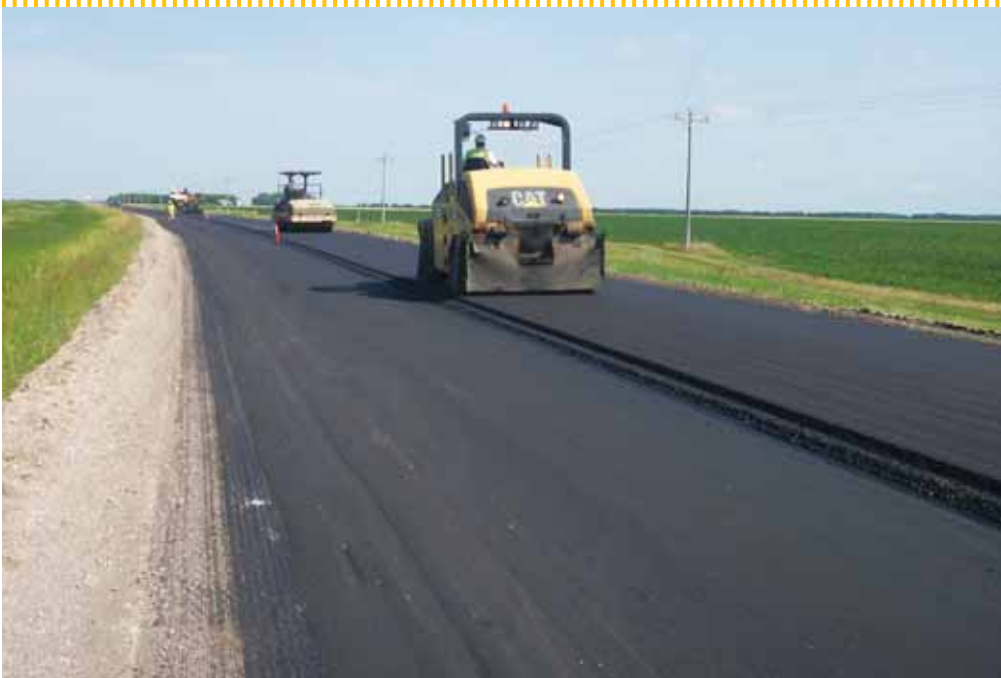
Knife River used Ingersoll Rand DD158 steel-drum rollers for intermediate and finish compaction after using a Cat 360 rubber-tire roller for the breakdown function and achieved 89% of the available bonus for smoothness and 98% of the available bonus for density.
