Sturdy mattress

Scour problem resolved at Kennedy Space Center

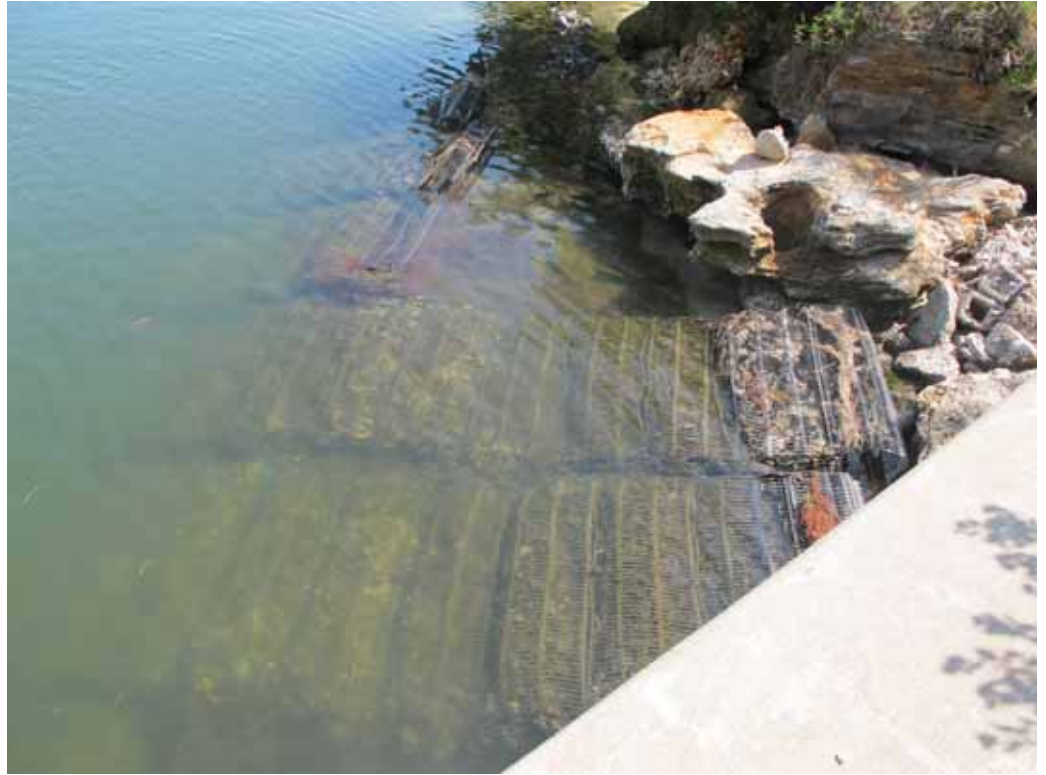
During the KSC project, 1,281 marine mattresses were utilized with the geosynthetic revetment systems at depths of approximately 20 ft amid strong currents and with limited overhead clearance using GPS. Even in the most demanding conditions, the mattresses had the strength and flexibility to armor the bridge piers without damaging them.

Due to the capability of customizing, depending on the pier, different sized mattresses were used. All were 5 ft wide and they varied in length, 10-20 ft long.

In high-flow conditions, the marine mattresses tend to be very stable. Trying to place material underwater and get a specified thickness of material in adverse conditions is always difficult. Having a unit like the marine mattresses that goes in as a discreet size that can be positioned using GPS ensures the contractor and engineer know that what was specified is actually what was installed.

Six inches of bedding stone was laid down first at the bottom of the piers for leveling purposes. Bedding stones are small pebbles, so the shipping costs

were much less than for the 300 lb of the limestone riprap. Lastly, the mattresses were assembled and placed using cranes by the piers.

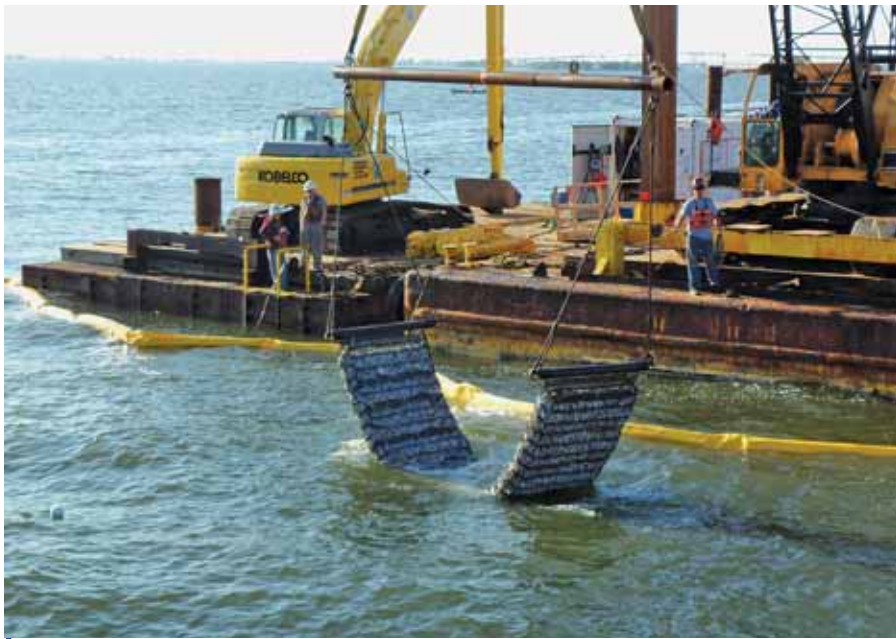
The marine mattresses were selected for their constructability, adaptability and durability in a challenging, submarine environment. Also, the coastal and waterway revetment system was much more cost-effective than the alternatives.

using select grades of copolymer (high-density polyethylene [HDPE] and polypropylene [PP]) resins that are highly oriented and resist elongation (creep) when subjected to high tensile loads for long periods of time. Polymeric geogrids provide high resistance to installation damage and long-term chemical or biological degradation. With this geogrid, the mattresses had the strength and flexibility to armor the bridge piers without damaging them.

NASA and Jones Edmunds and Associates also selected the reinforcement systems because the units could be locally constructed and customized on shore prior to installation and could be conformed around fenders or circular piers.
